LIFT STATION CHECK-UPS: THE DOCTOR IS IN

Applied Technologies, Inc.

Town of Norway Sanitary District No. 1

OCTOBER 17, 2018

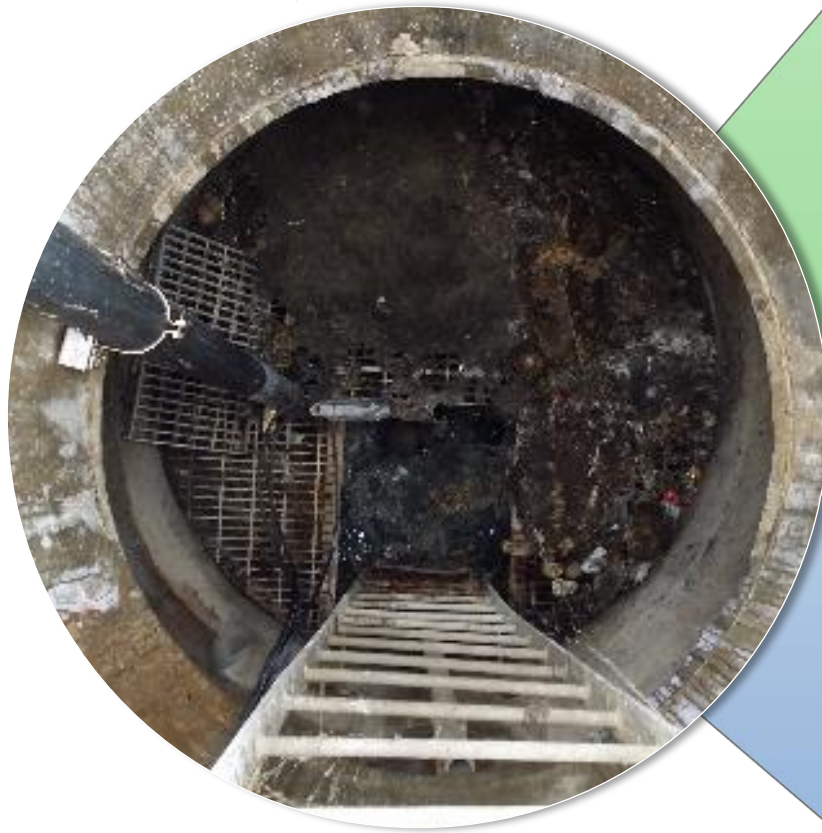
PHYSICAL EXAM: WET WELL

- Entrance concrete: Good
- Interior: Unable to view
- Grating: Covered with grease and debris
- Cover underside: Significant corrosion
- Grease and odor: None

- Enter the wet well to assess concrete and grating
- Cover corrosion: No immediate concerns

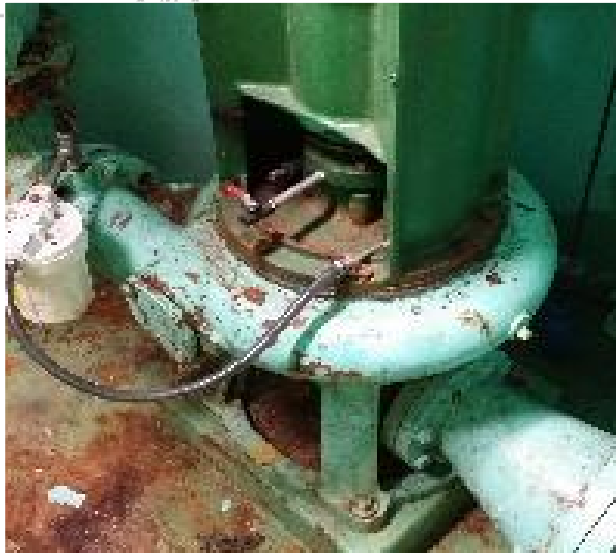
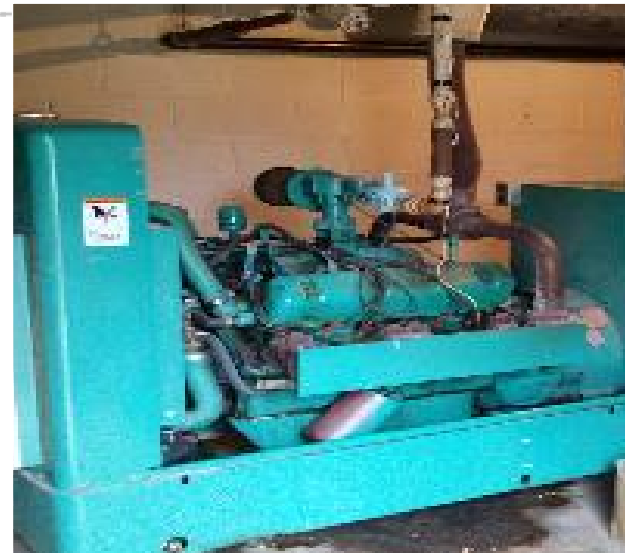
PHYSICAL EXAM: DRY WELL

- Entrance: Significant corrosion
- Floor: Significant corrosion
- Pumping equipment: Insufficient capacity, corrosion, poor access
- Piping and valves: Operational issues

- Install higher capacity pumps
- Replace with new submersible lift station and valve vault

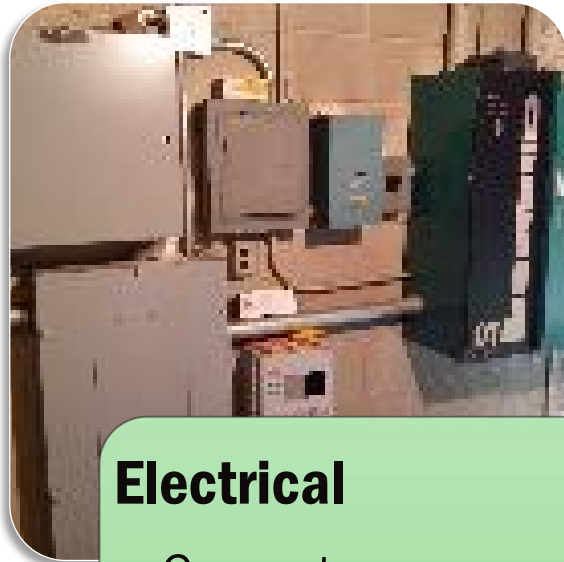
Electrical

- Generator: Good condition, but exceeded design life
- Replace with new station

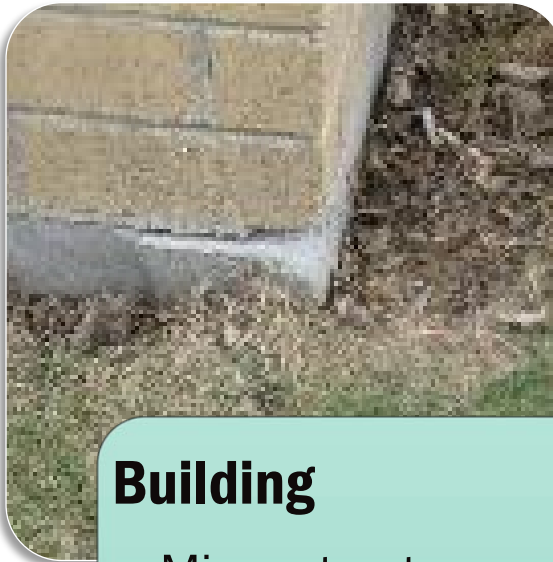
Building

- Minor structure damage
- HVAC in good condition

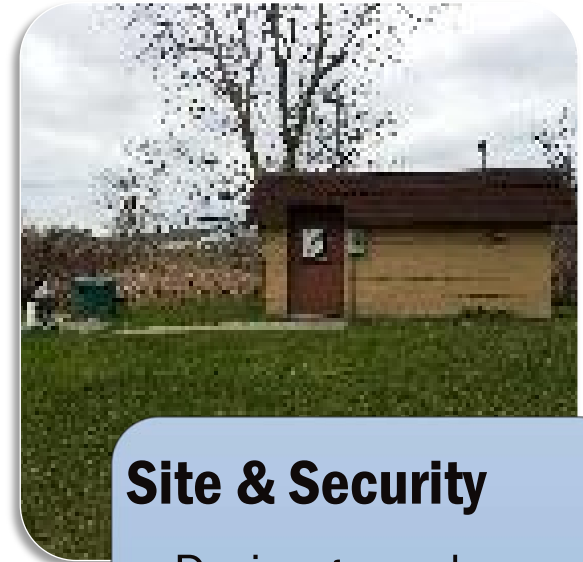
Site & Security

- Drainage and access issues

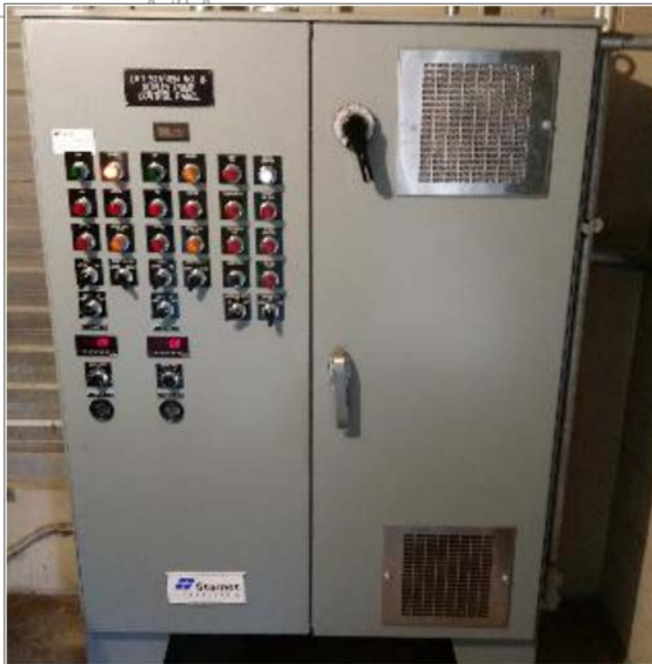
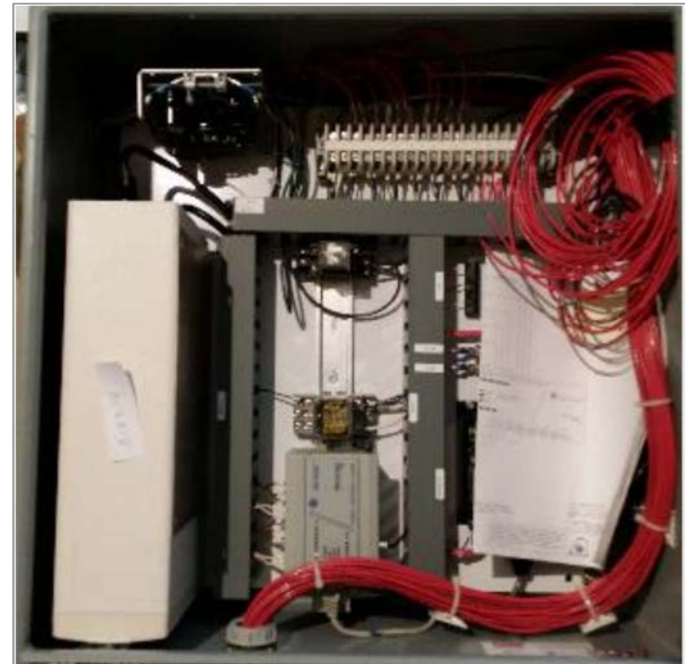
PHYSICAL EXAM: CONTROLS AND COMMUNICATION

- Control panel: End of design life
- Control devices: Control levels drift
- Flow monitoring: None installed

- Replace controls and panel with new station
- Install flow monitoring
