Main Lift Station Force Main Assessment and Repair
City of Ashland, WI

Randy J. Langer, P.E. – Strand Associates, Inc.
2015 WWOA Conference

October 8, 2015

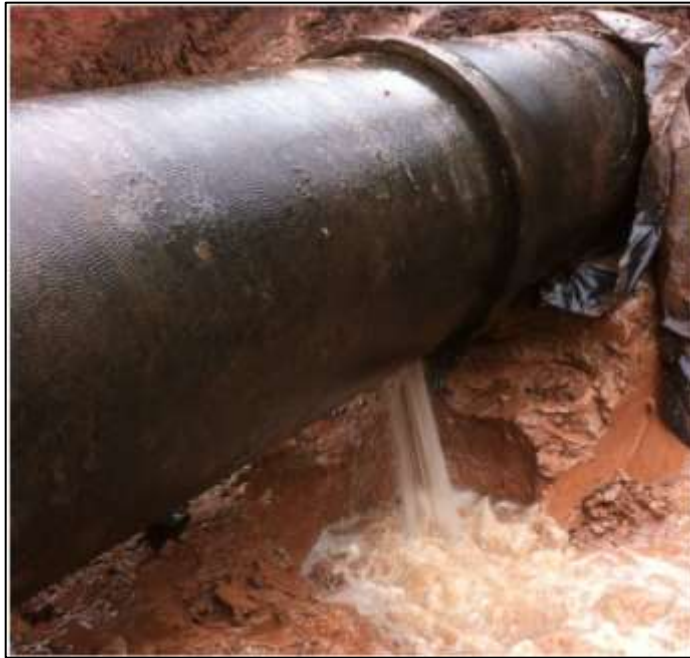
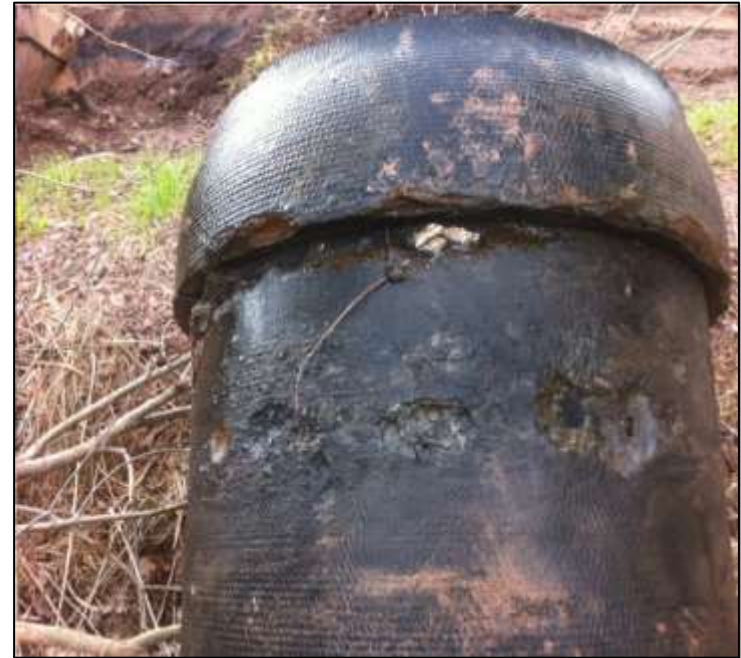
Main Lift Station Force Main Failure History

- First Leak – Fall 2012
- Second Leak – May 2013
- Two additional leaks suspected in 2013
- All leaks emerged during periods of high flow
- Mode of failure appeared to be external corrosion
