2016 WWOA Annual Conference

Cost Effective Private Property I&I Reduction Case Study - Wauwatosa, WI

Cost Effective Private Property I&I Reduction Case Study–Wauwatosa, WI

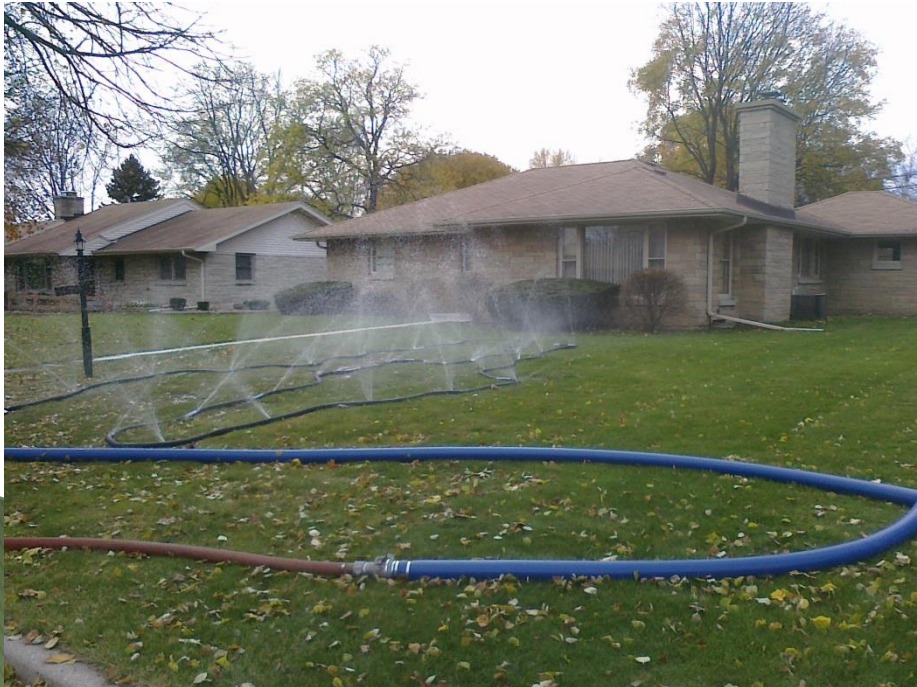
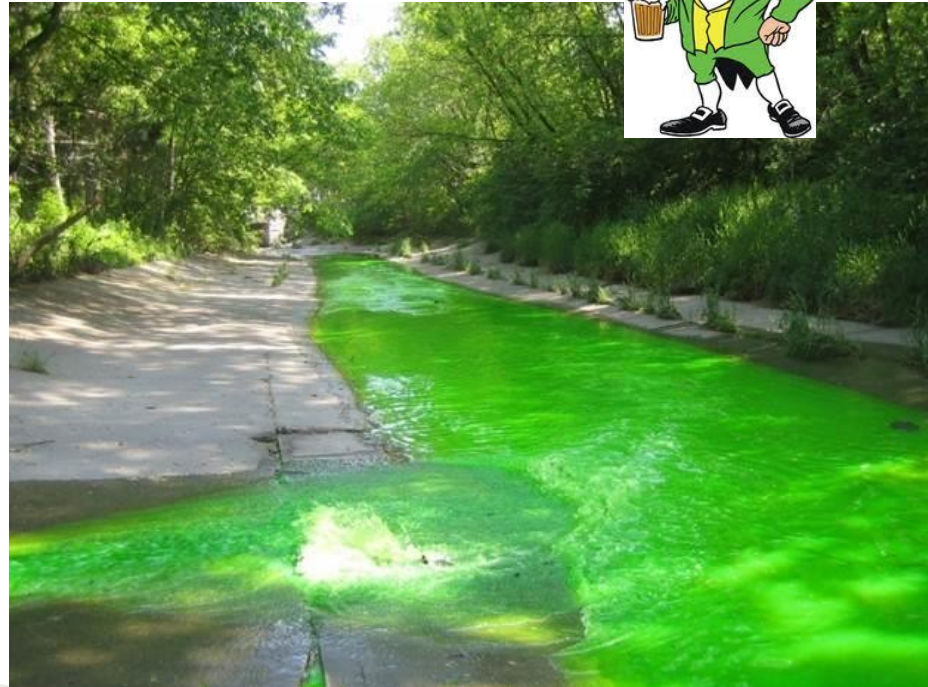
- Multi-phase investigative approach with rehabilitation
 - CCTV required as part of selected rehabilitation method
 - Rain event simulation:
 - Soaker Hose & Storm Sewer Dye Flooding
 - Flow monitoring – V-notch weir flow meter

Soaker Hose and Dyed Water Test

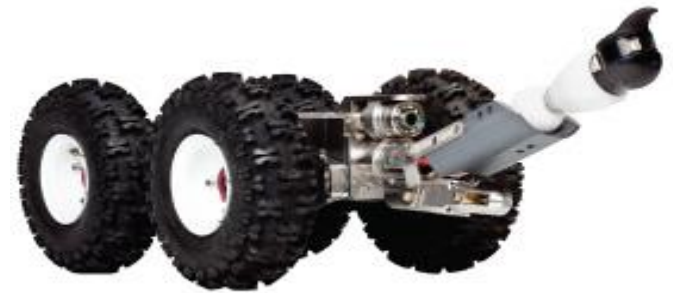
Round 0 (Pre-Rehabilitation)

- Establishing Baseline Flows
 - 2011 storm sewer dye flooding
 - Manholes Surcharged to casting
 - Round one of soaker hose testing
 - 3" per hour simulated rain event
 - Soaker hose components
 - Nearby hydrants
 - LETS camera inspections
 - Lateral leak location detection

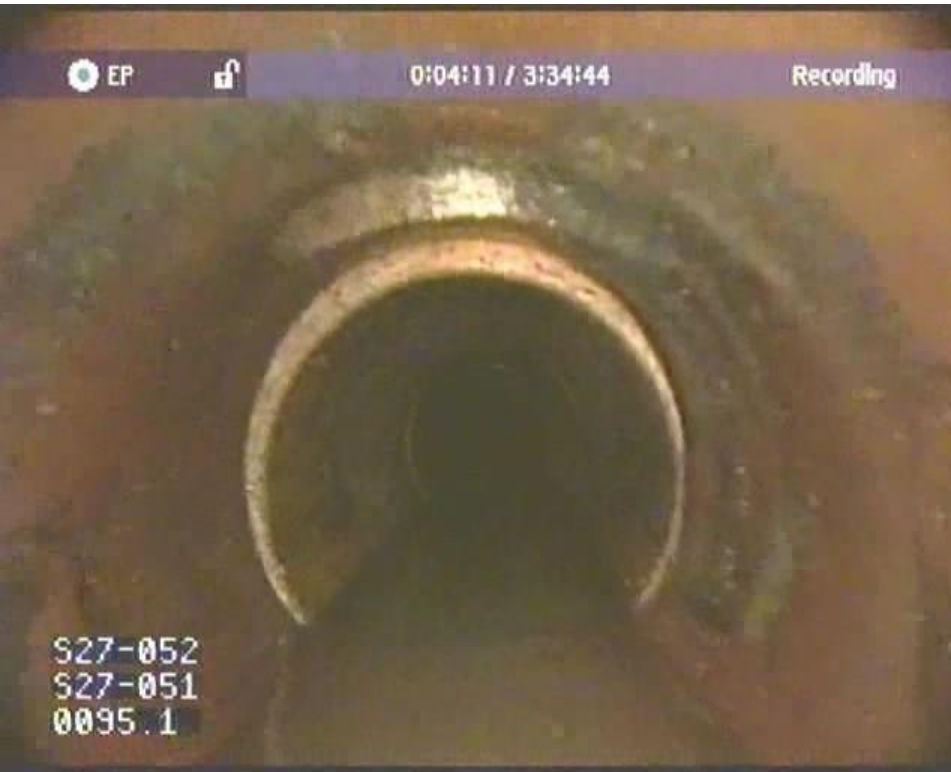
Sewer main & lateral connection
prior to dye flooding

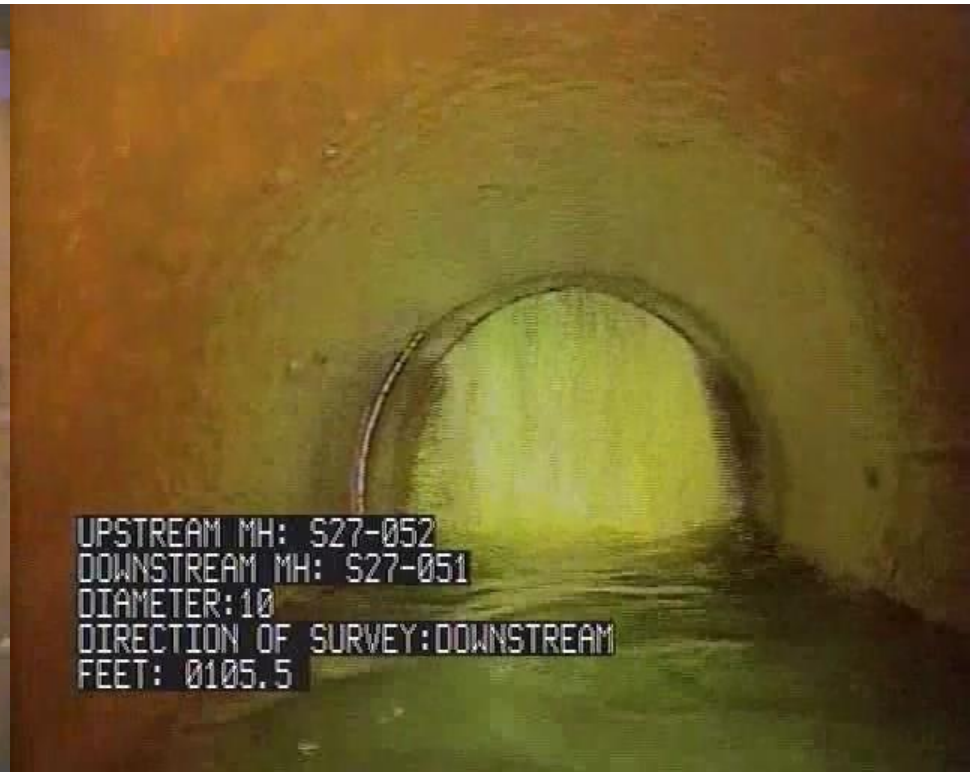
Sewer main & lateral connection
during dye flooding

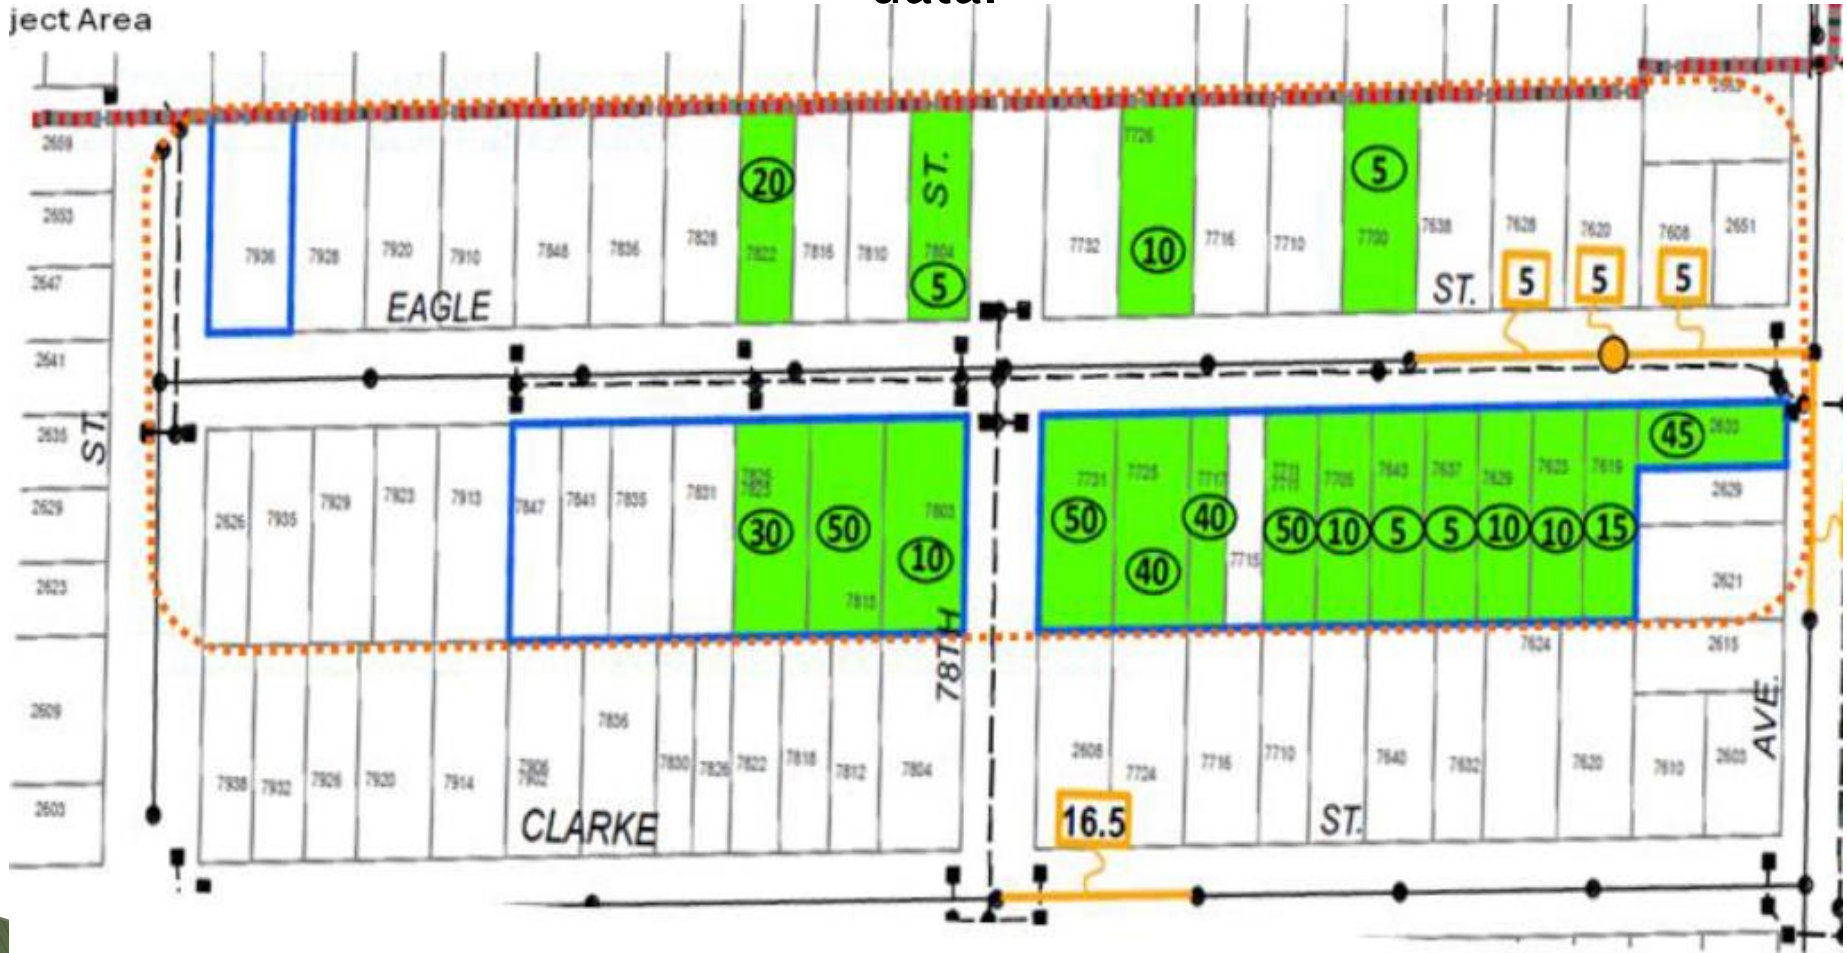
City of Wauwatosa PPII Investigative Pilot Project

Eagle St. (Between 76th St. & 80th St.)–2011 storm sewer dye flooding data.

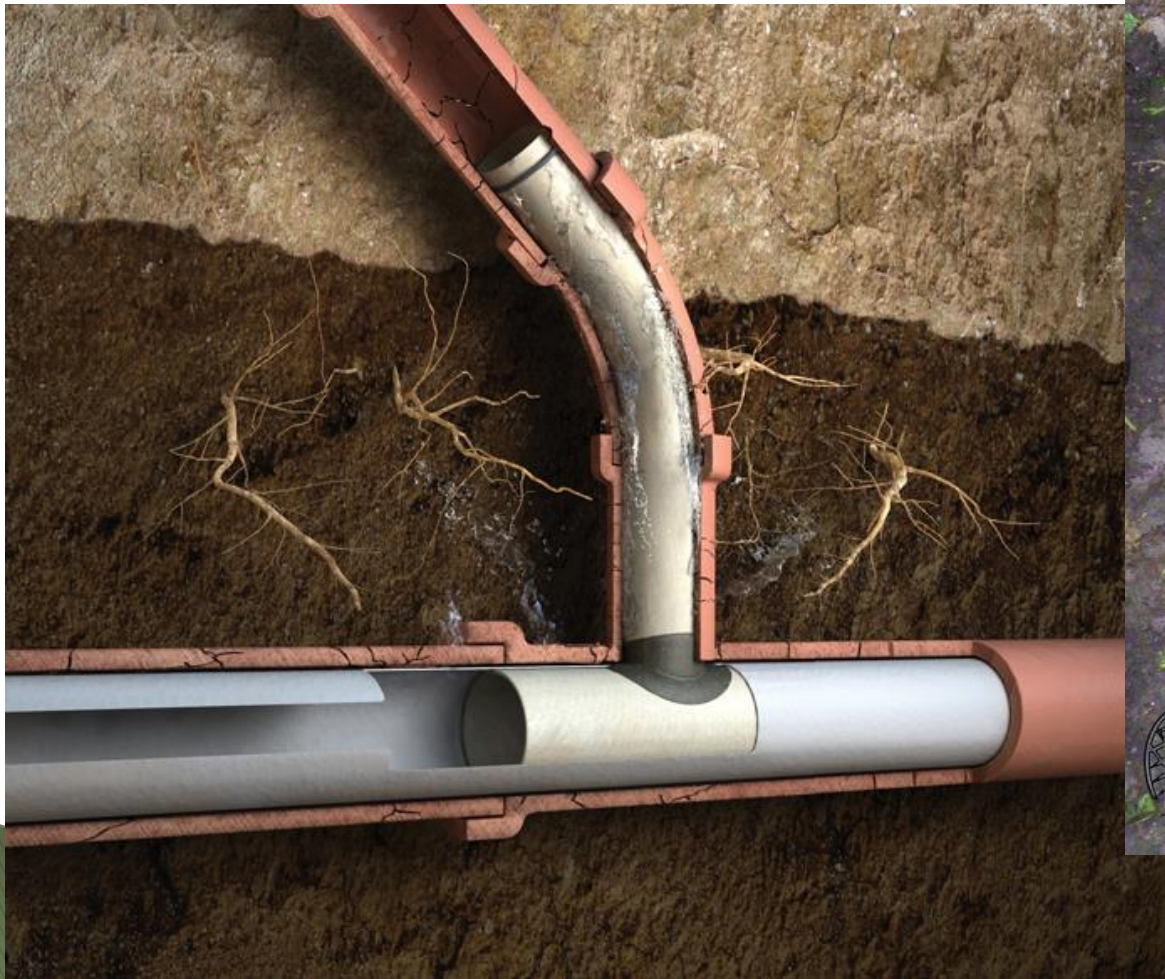
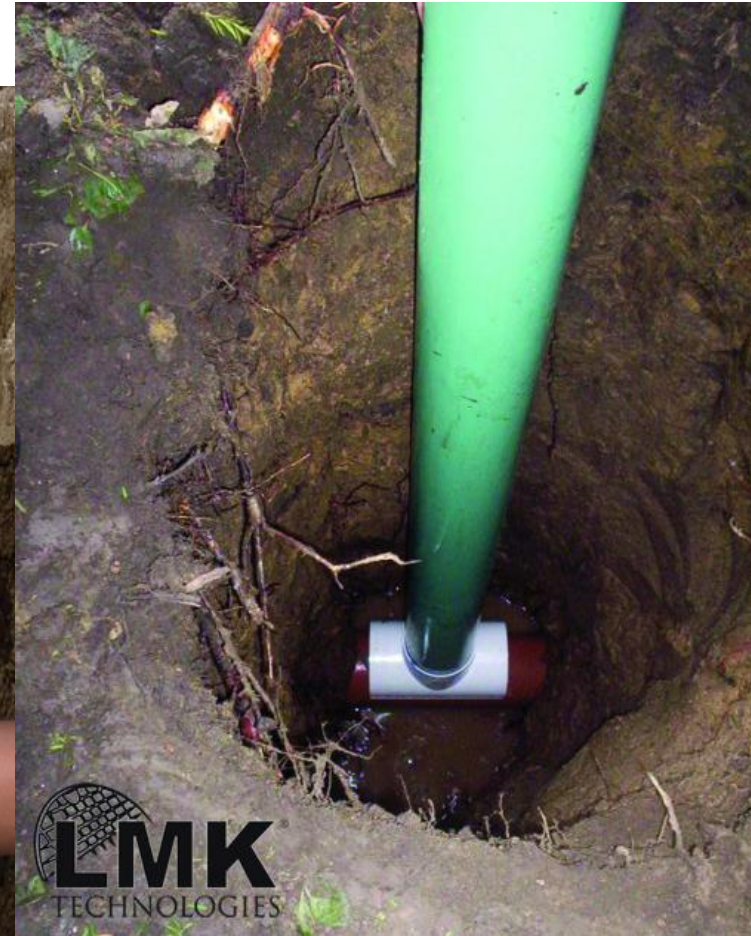
Lateral T-Liners & Vac-A-Tees

- T-Liner limited length without Vac-A-Tee upstream
- Up to 200' with a Vac-A-Tee

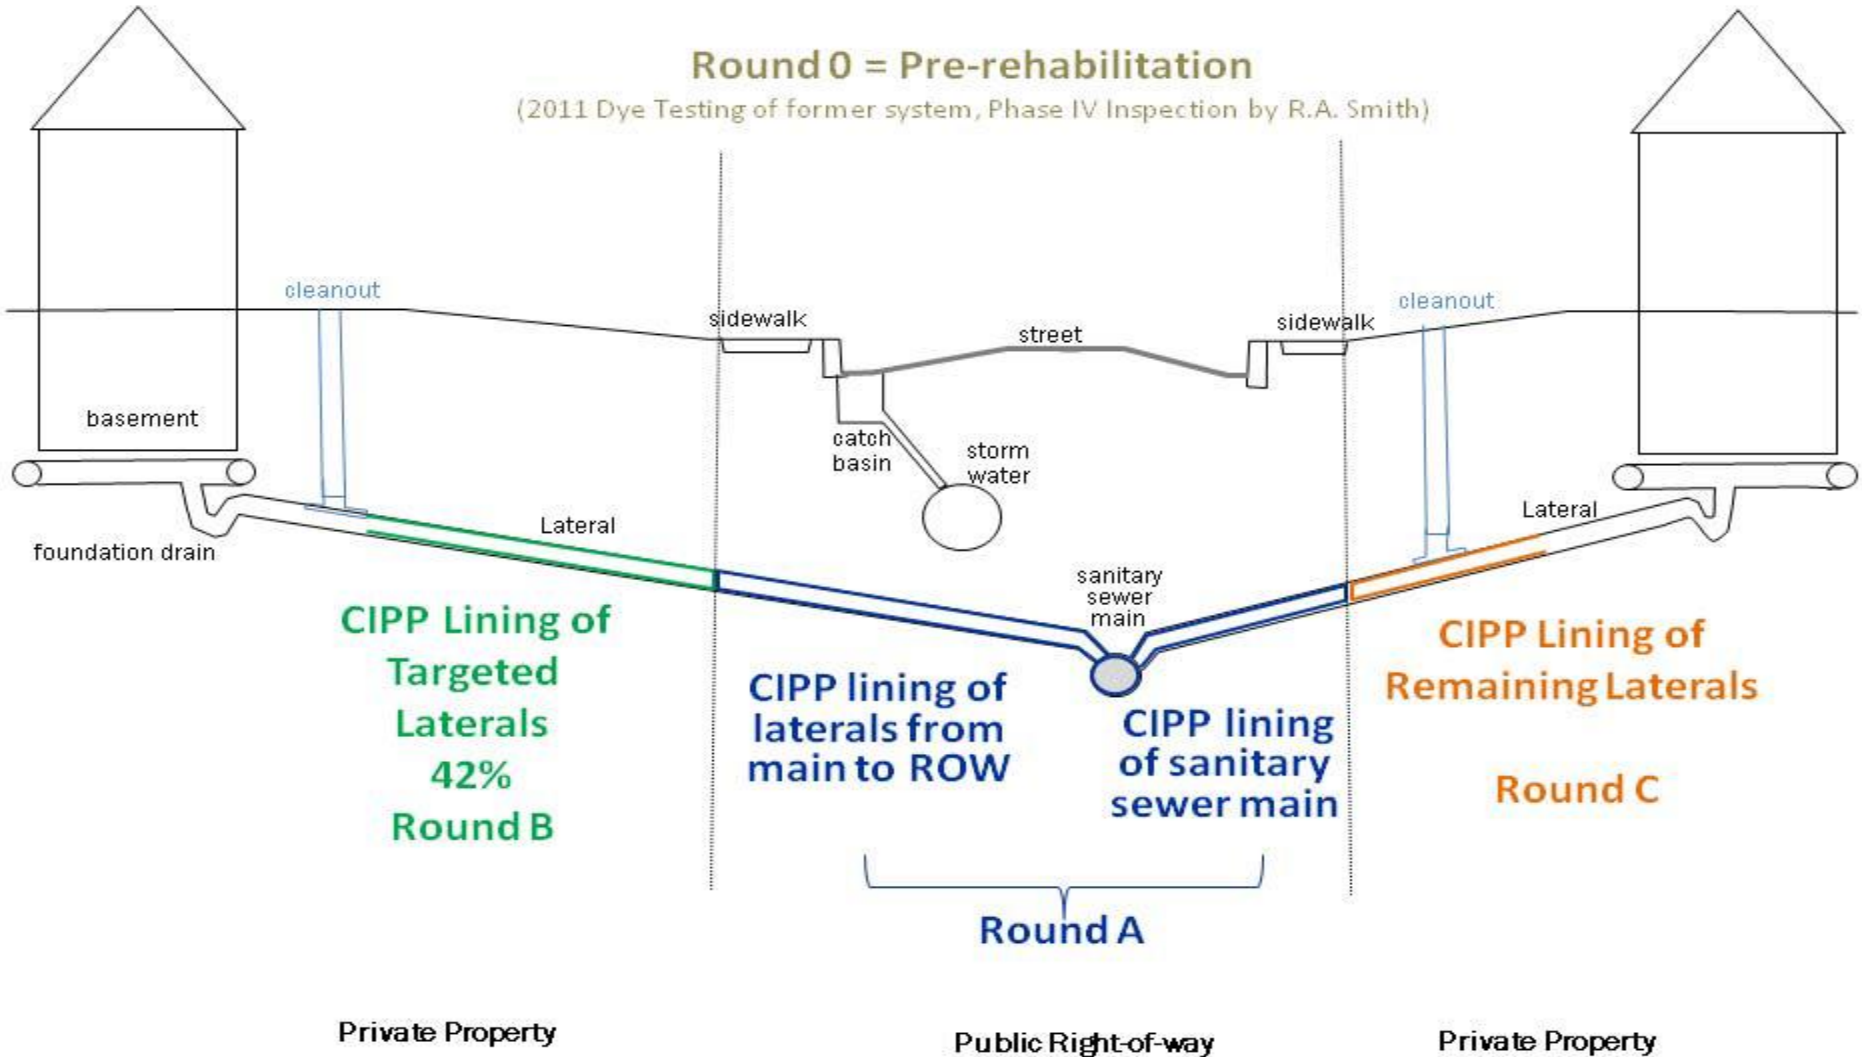
Eagle St.-Project Implementation Diagram

Round 0 = Pre-rehabilitation

(2011 Dye Testing of former system, Phase IV Inspection by R.A. Smith)

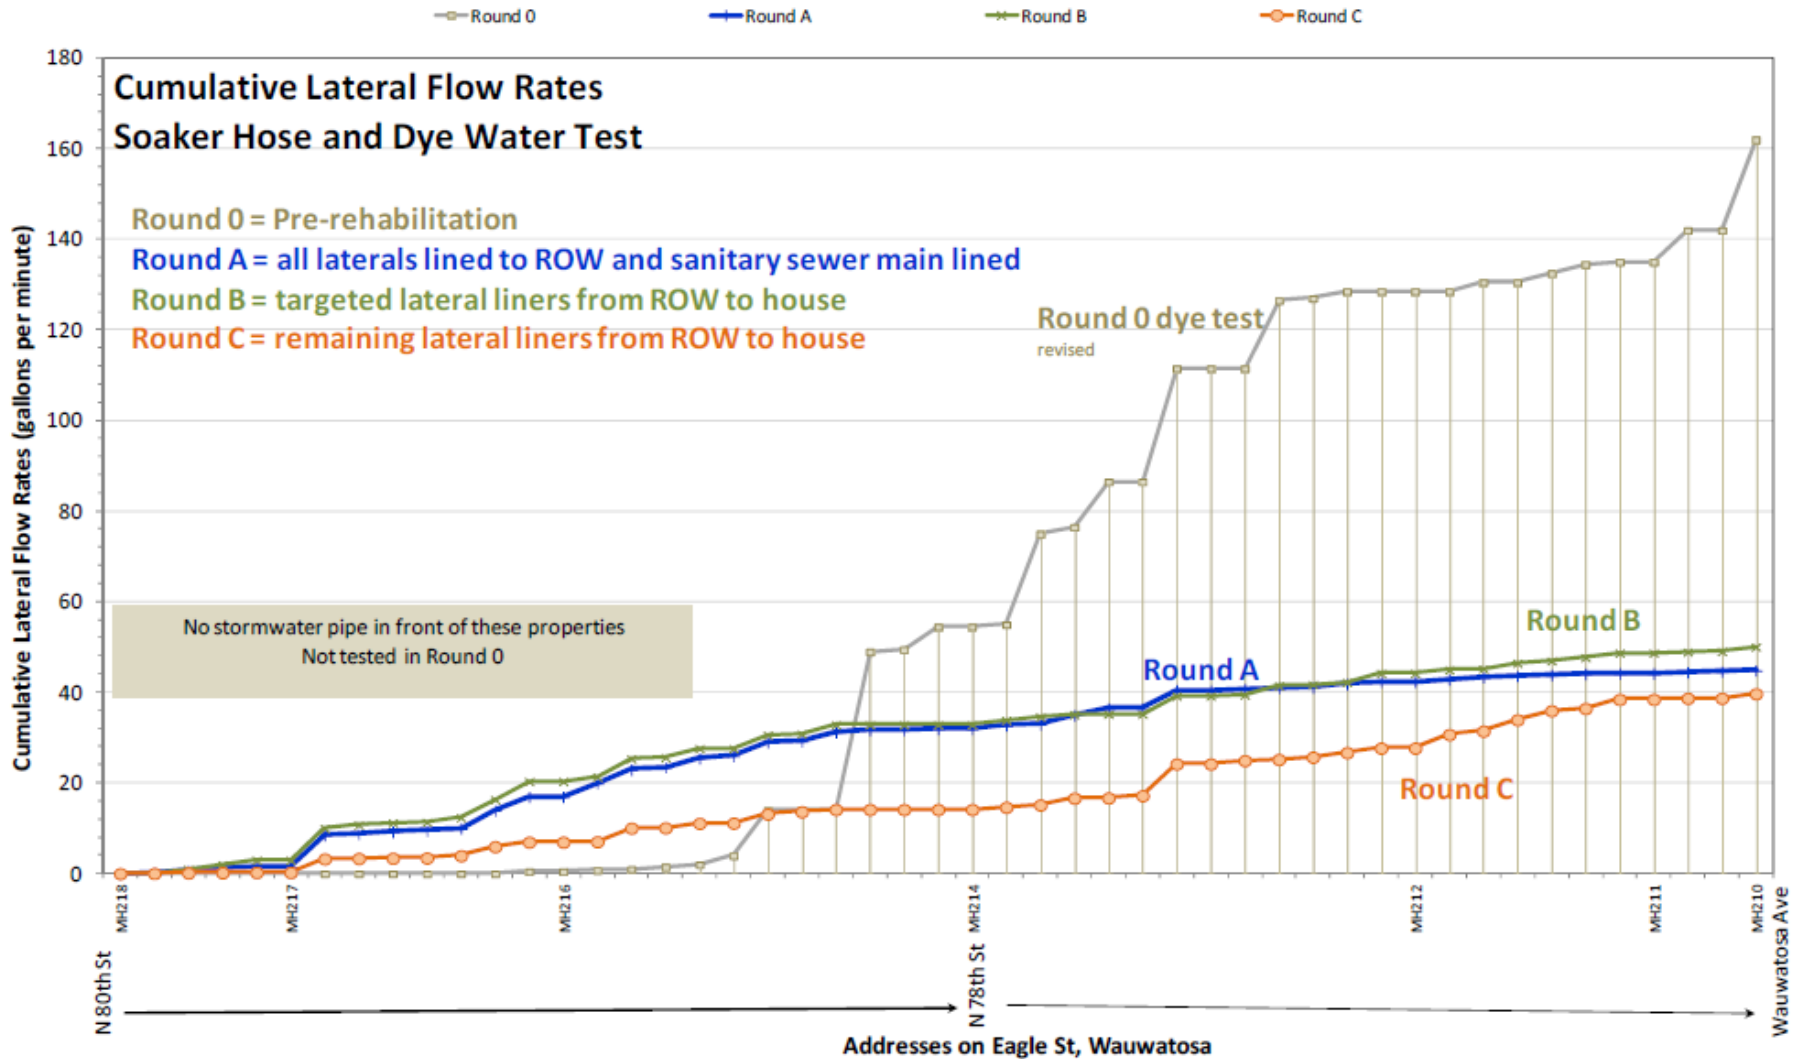
Total Infiltration Reduction Diagram

- Average of 75% cumulative PPII reduction
 - Foundation drains and sump pump connections
 - Majority of PPII reduction achieved in the ROW
- Estimated larger scope lining costs:
 - Sewer main to the ROW – \$4,700.00
 - Sewer main to the upstream access point– \$6,000.00
- Not cost effective solely for PPII reduction

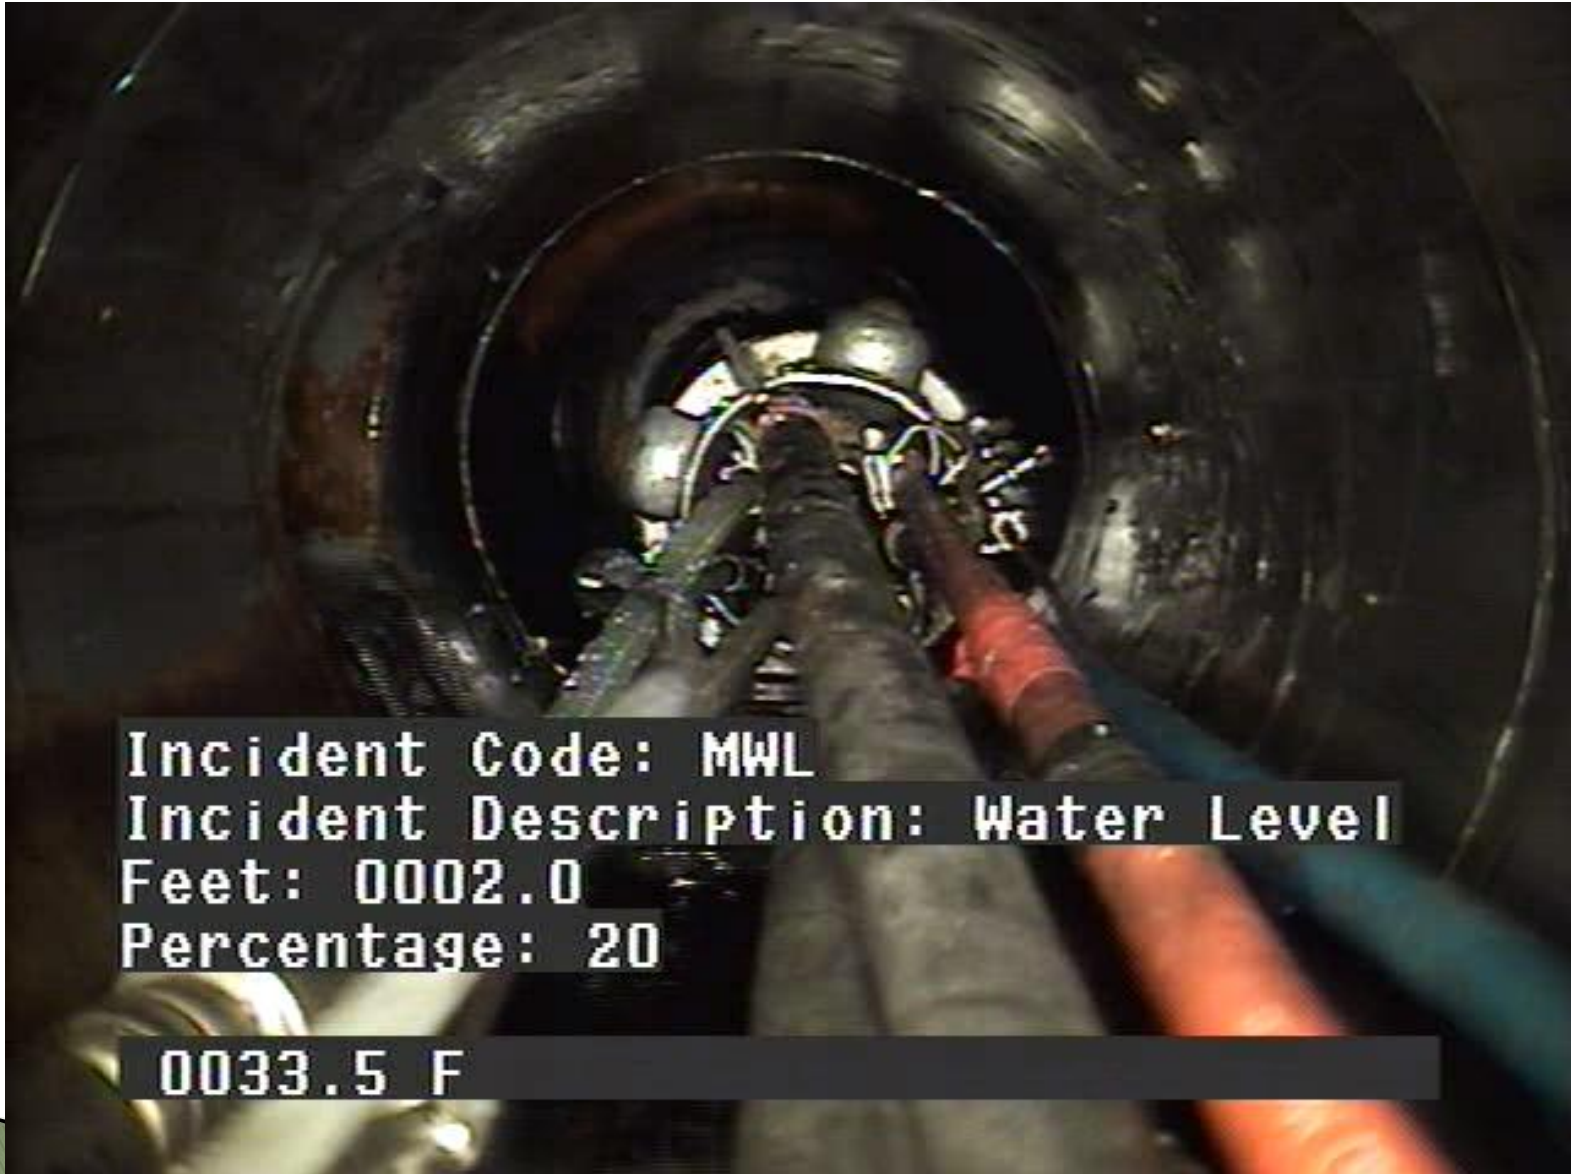
Lateral Grouting Example

Incident Code: MWL
Incident Description: Water Level
Feet: 0002.0
Percentage: 20

0033.5 F

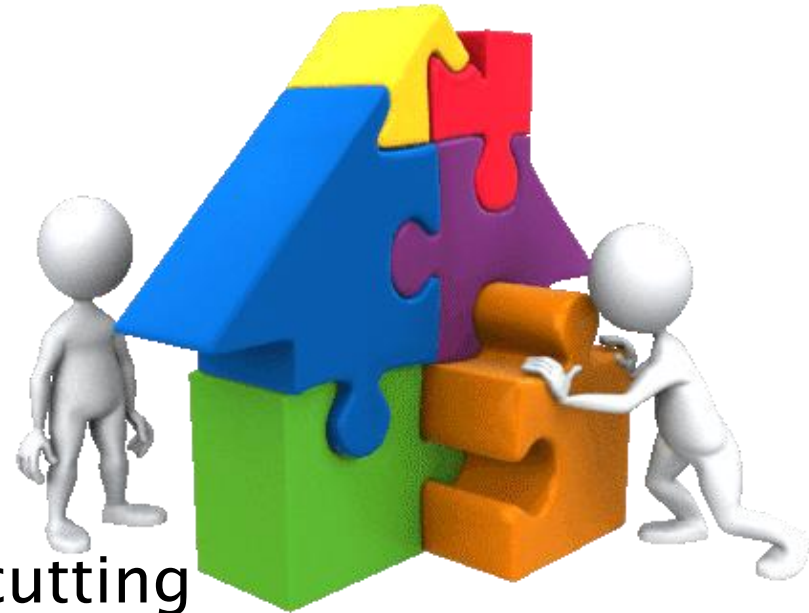
Wauwatosa – Lateral & Lateral Connection Grouting Projects 2012–2014

- Grouting Challenges:
 - Protruding laterals
 - Root & deposit blockages
 - Structural defects
 - Tuberculation
- Solutions:
 - Mainline & Lateral jetting/cutting
 - Excavation or elimination?
