Pump repair options & alternatives

Presented by Bob Gaskey
of

Course Overview

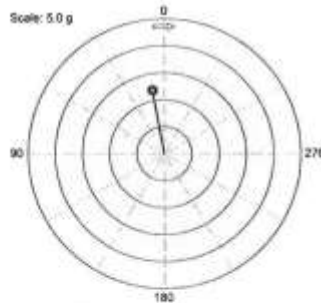
Balance report

Both planes between supports (Tolerance in correction planes)

ISO G2.5

1800 RPM

- 2.383 g at 10°

- 1.775 g at 151°

OK (0.67 x Tol)

OK (0.51 x Tol)
