Main Lift Station Force Main Assessment and Repair
City of Ashland, WI

Randy J. Langer, P.E. – Strand Associates, Inc.
2015 WWOA Conference

October 8, 2015

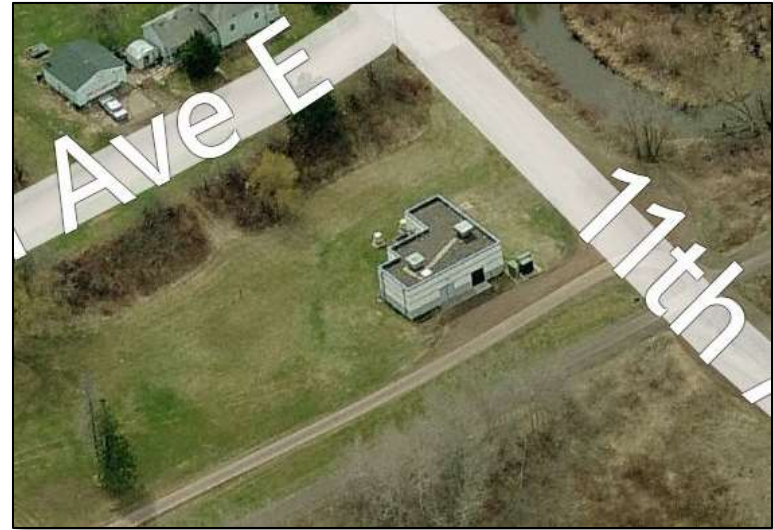
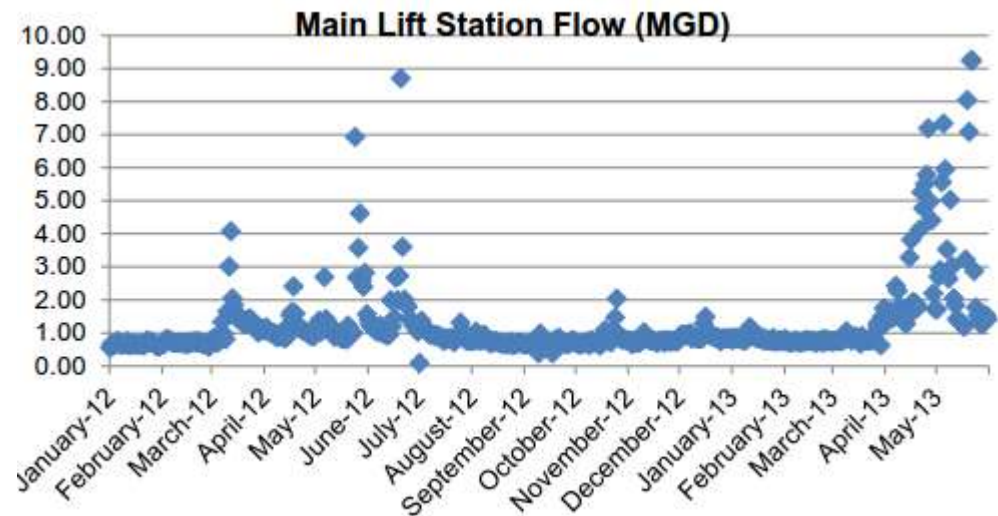
Main Lift Station Force Main

- Constructed in 1991
- Ductile iron
- 24 inch diameter
- 5,252 feet long
- Six 150 hp pumps
- Serves more than 80% of City
- Flows in excess of 10 mgd during wet weather events

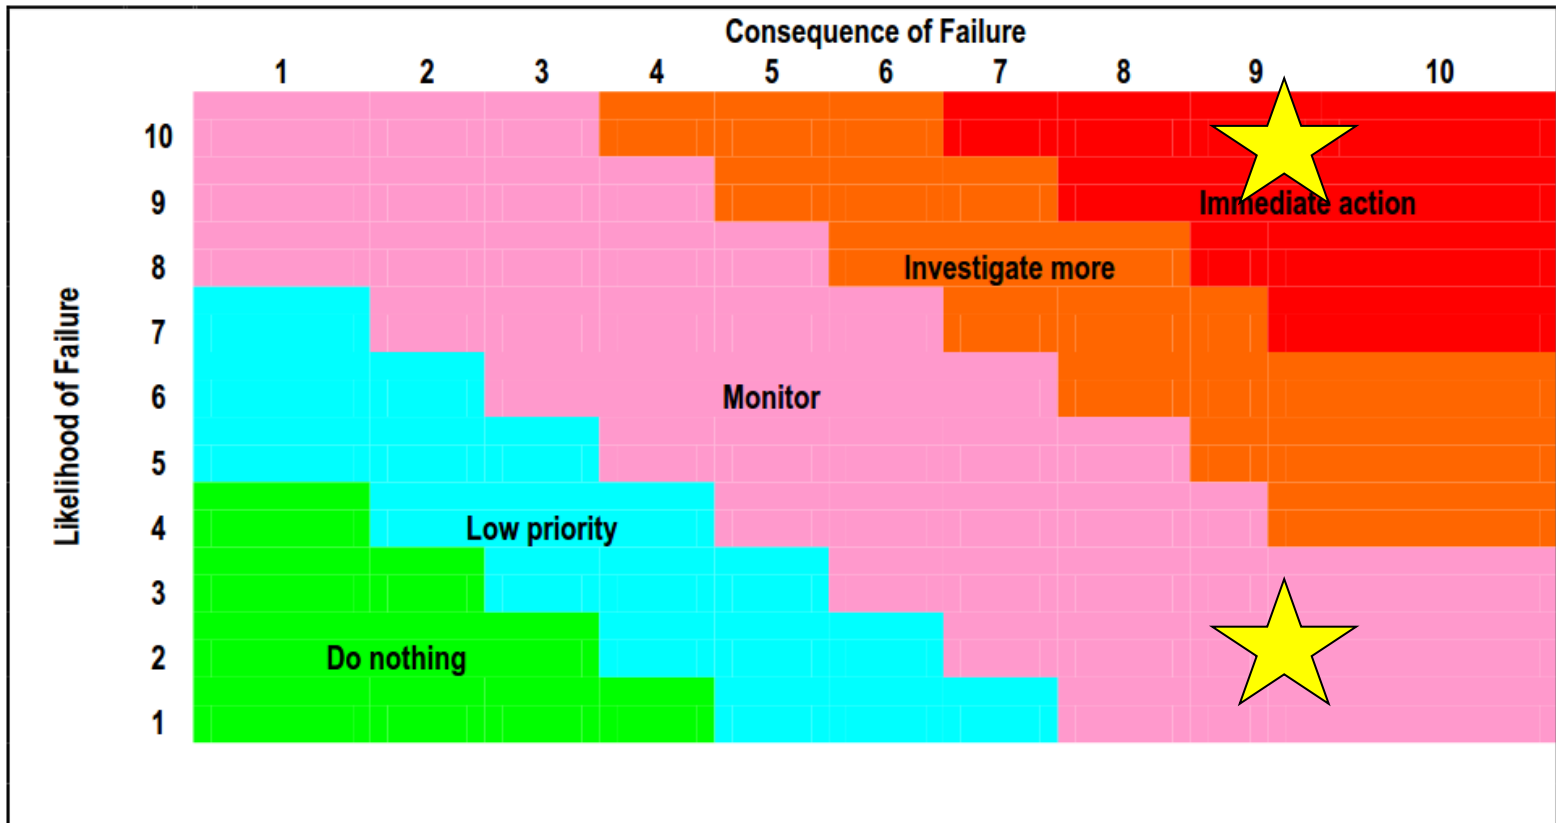
Ashland Force Main Assessment - Findings

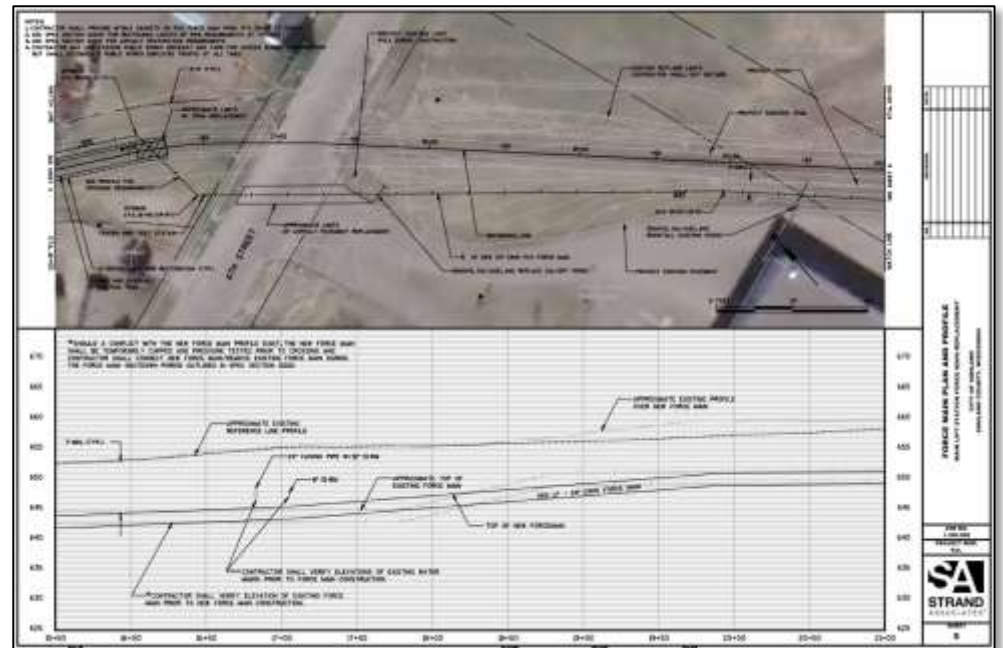
New Force Main Construction

- Fall 2014, restoration in spring, 2015
- Approximately 1,500 feet
- 24 inch C905 PVC
- Petroleum contaminated soils – nitrile gaskets
- Wrap ductile fittings, add sacrificial anodes
- Existing force main location

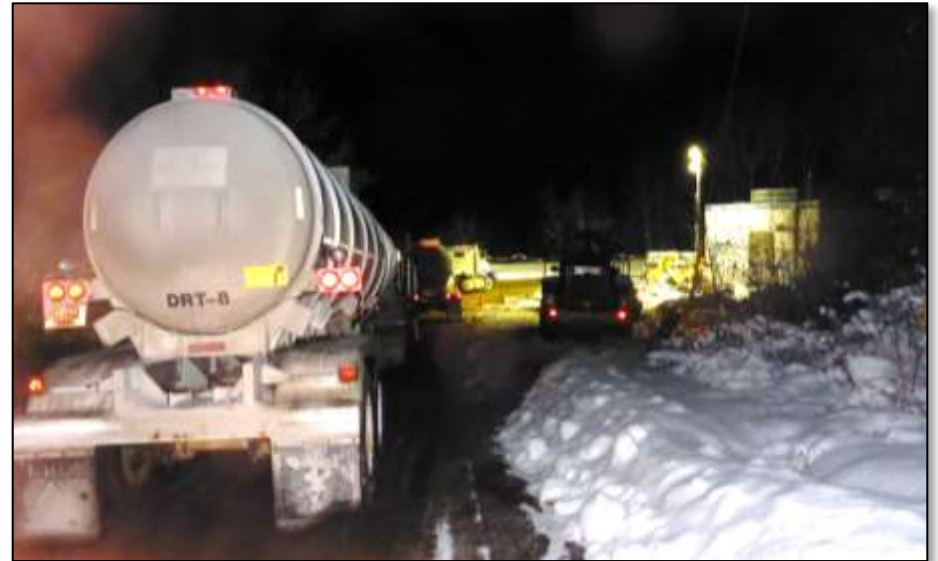
Final Tie-Ins and Bypassing

- November 12th-13th
- Three tie-in locations
- Cold and snow! – Not good for pumps!
- Low flow – overnight
- Three 8-inch pumps, 5 tankers, 3 septic haulers
- Multiple loading and discharge locations
