Wisconsin Wastewater Operators' Association – SE Regional Meeting

No Longer “Out of Sight, Out of Mind”: Force Main Condition Assessment

Randy Langer, P.E., Strand Associates, Inc.®

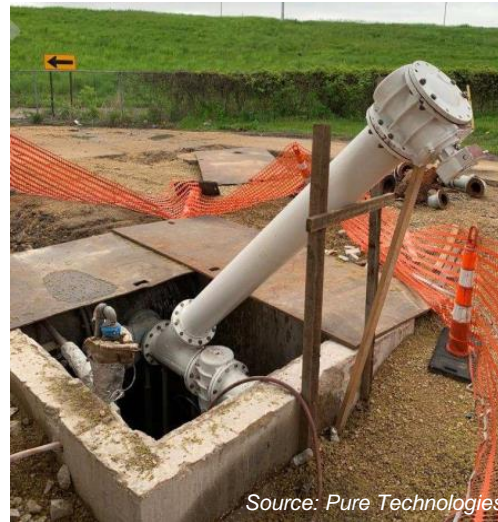
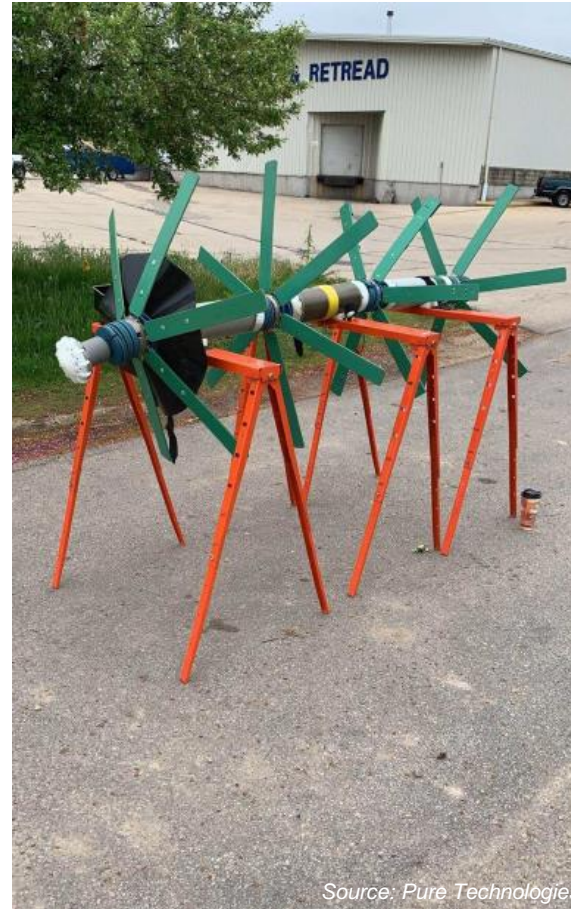
Electromagnetic Assessments Can Identify Wire Breaks and Deterioration of Cylinder in Prestressed Concrete Cylinder Pipe

- More significant access requirements
- Manual (out of service) or pumped through

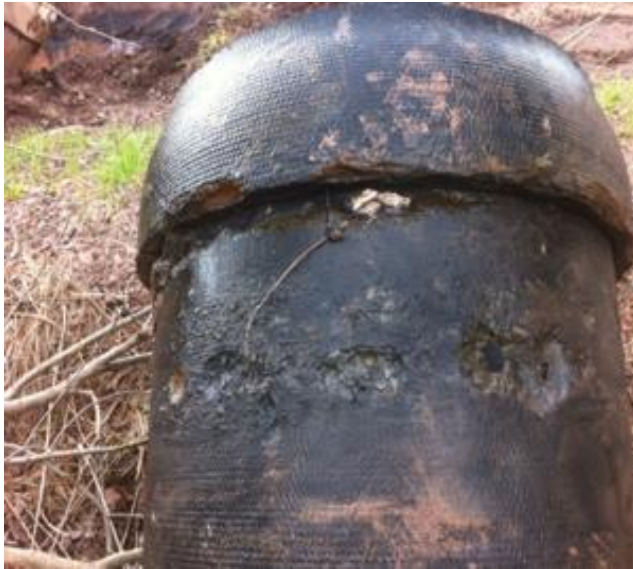
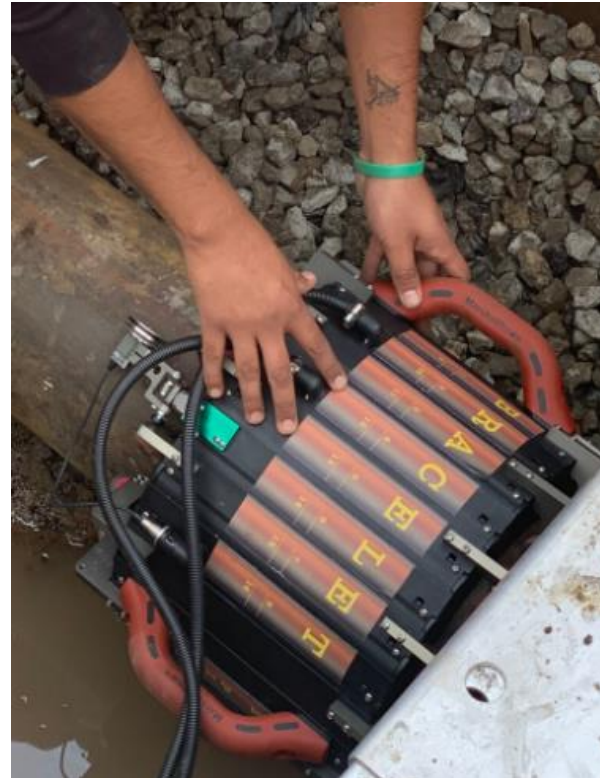
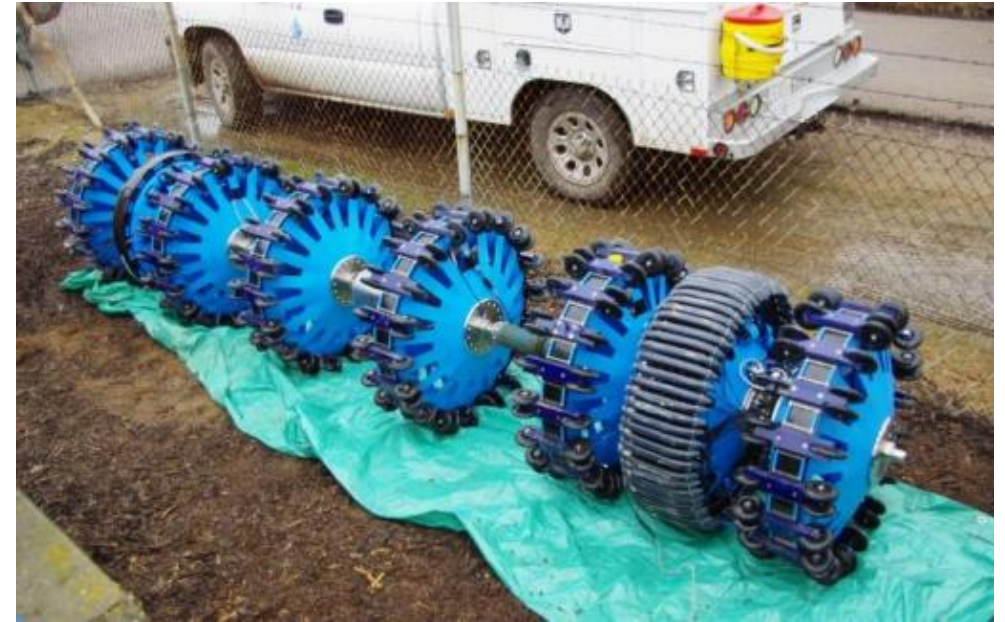
Electromagnetic Assessments Can Also be Used to Identify Wall Loss in Metallic Pipes

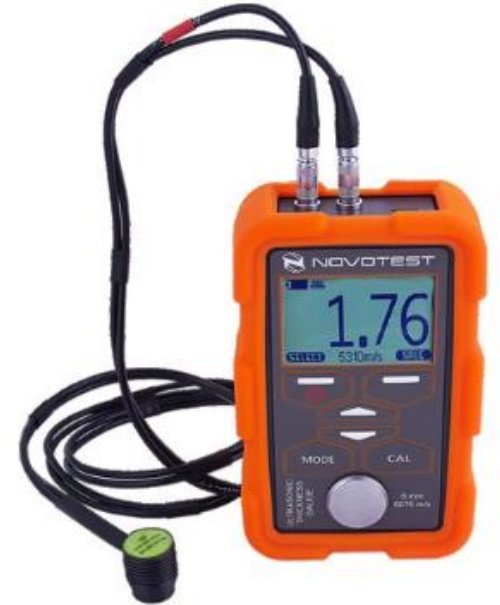
Ultrasonic Inspection Can Provide Additional Data

- Sends and collects sound waves
- Measures:
 - Geometry of pipe
 - Joint deflection
 - Anomalies in wall of pipe

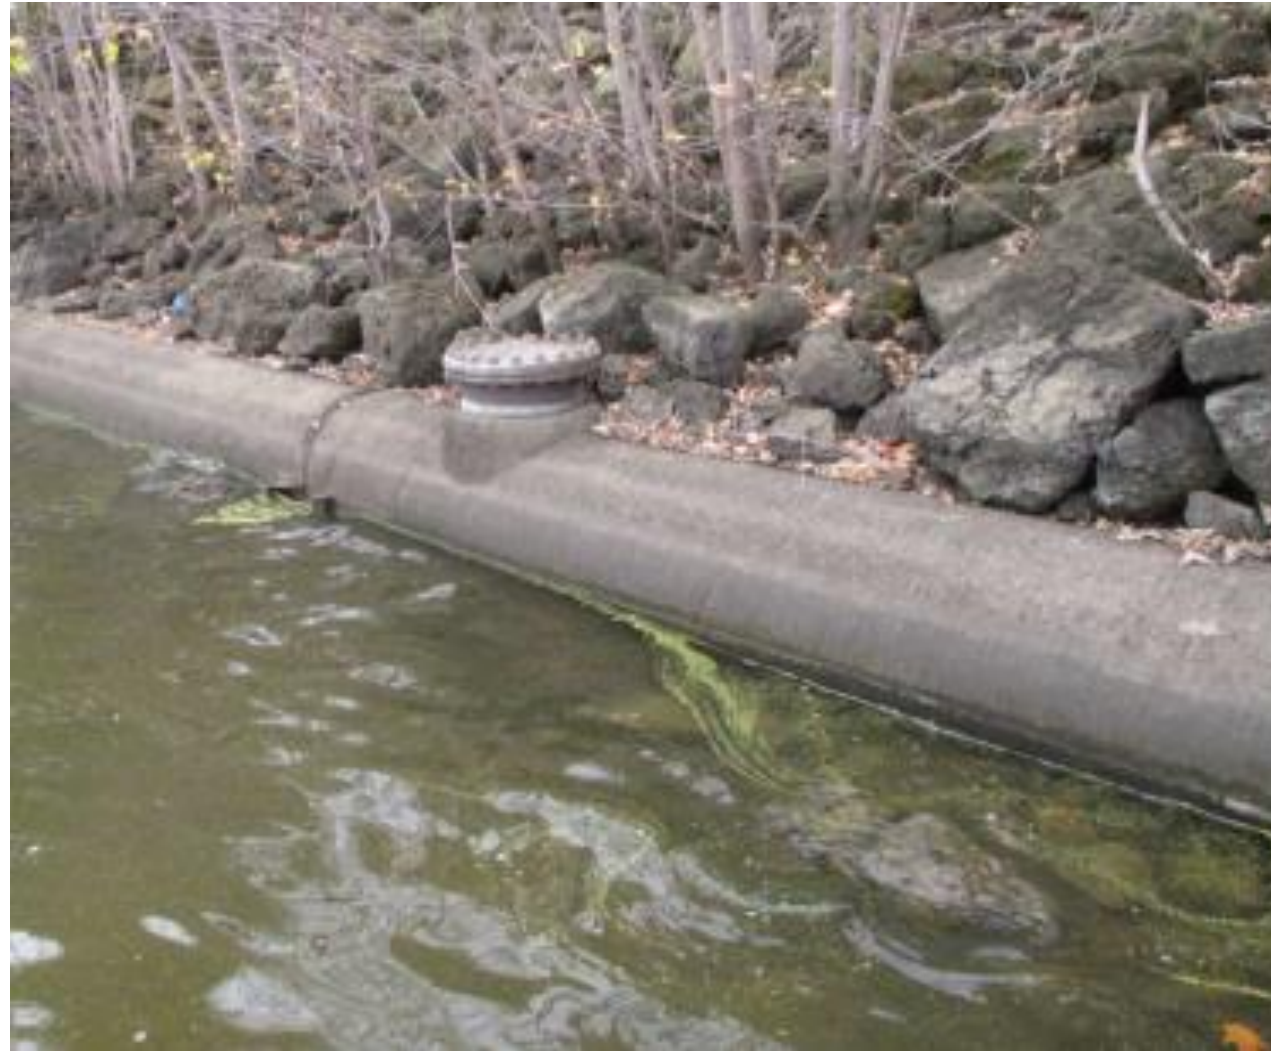
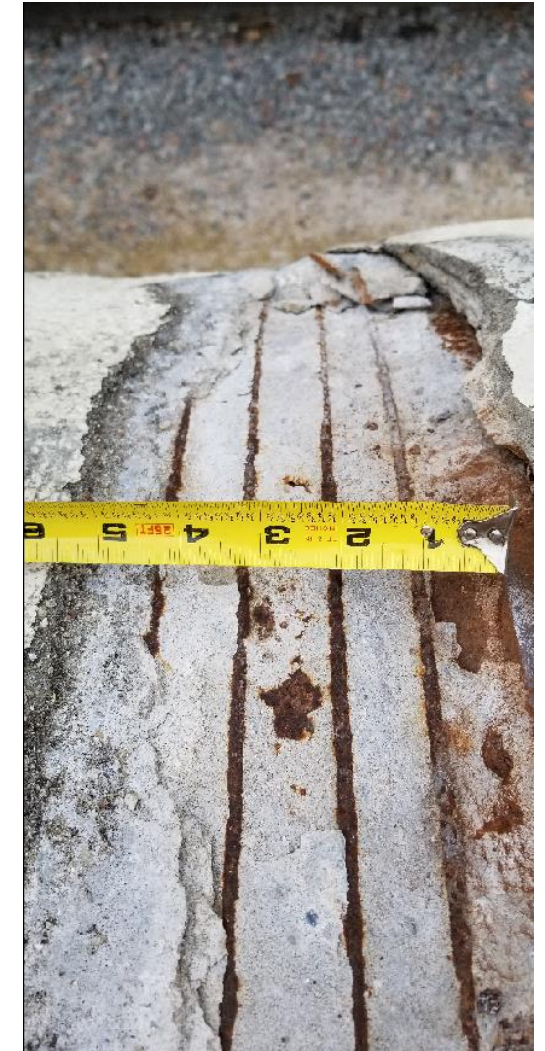
Visual Assessment Provide Significant Information

- Potholing
- Sounding
- CCTV

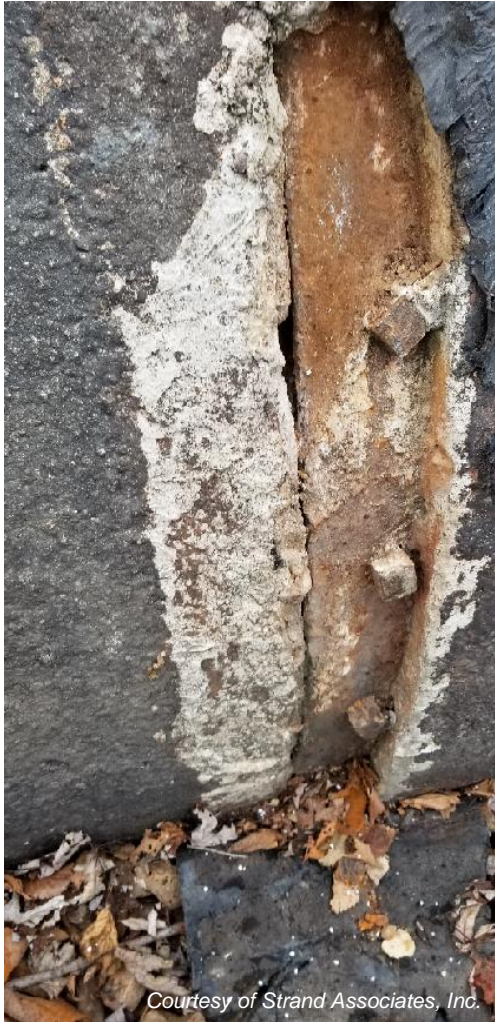
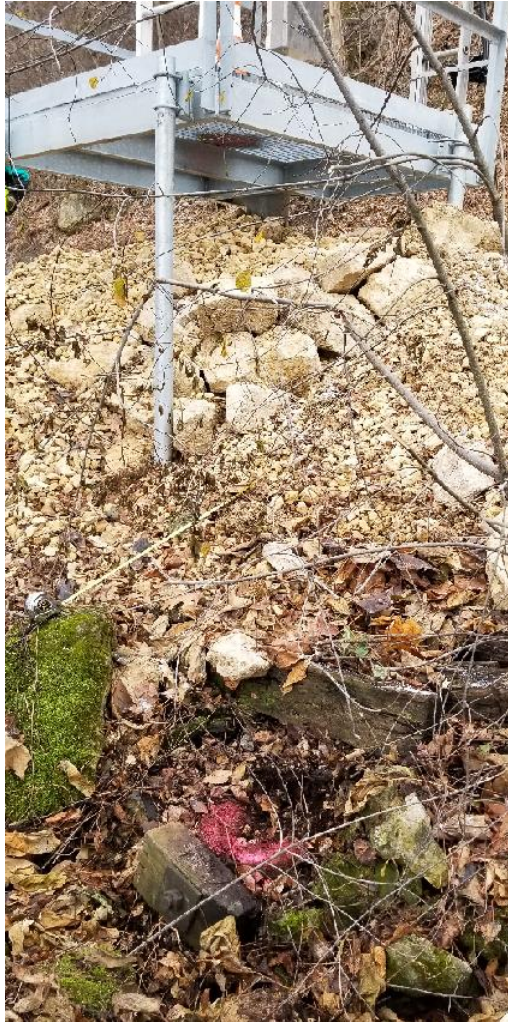
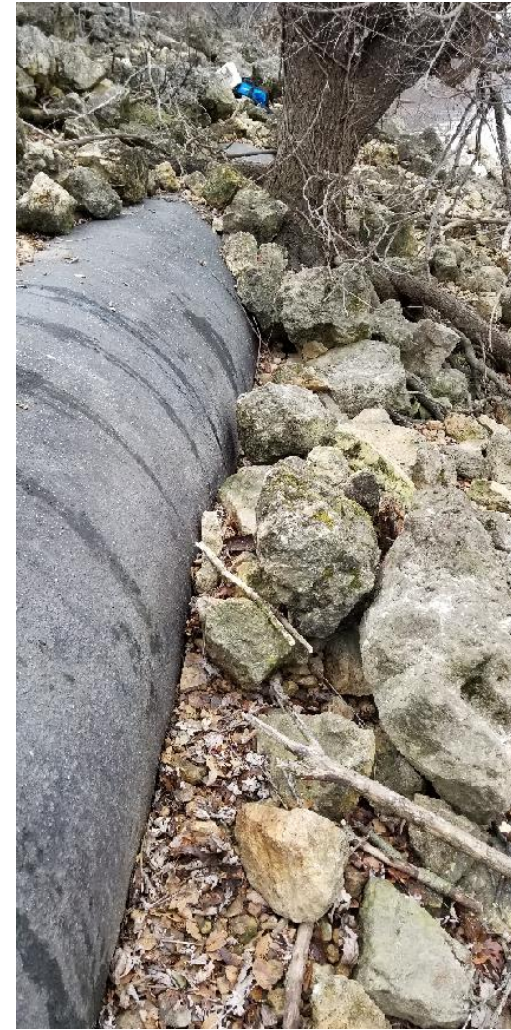
Dubuque, IA: Walk Through Identified Issues

- Repair areas of exposed prestressing wire
- Remove trees growing around pipe
- Restore proper cover material and rip rap above pipe (Army Corps of Engineers Project)
- Replace combination air/vacuum valves and surge relief valves

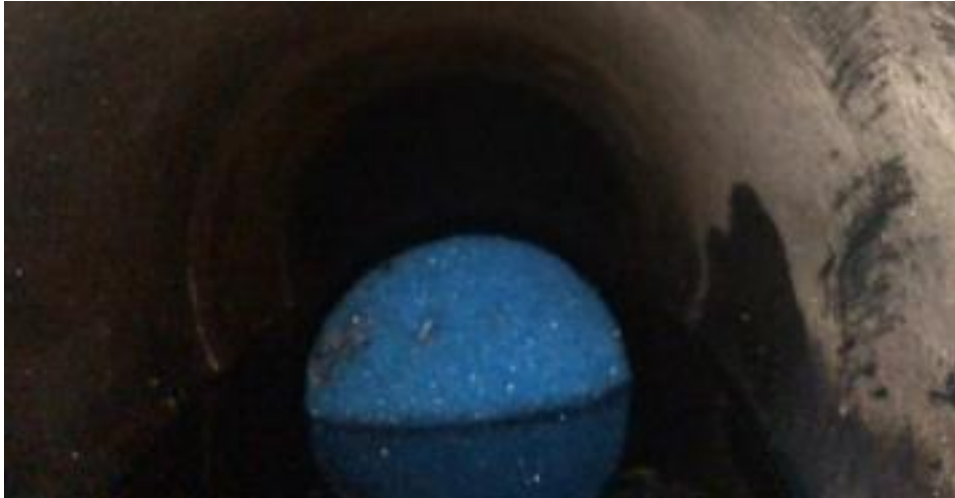
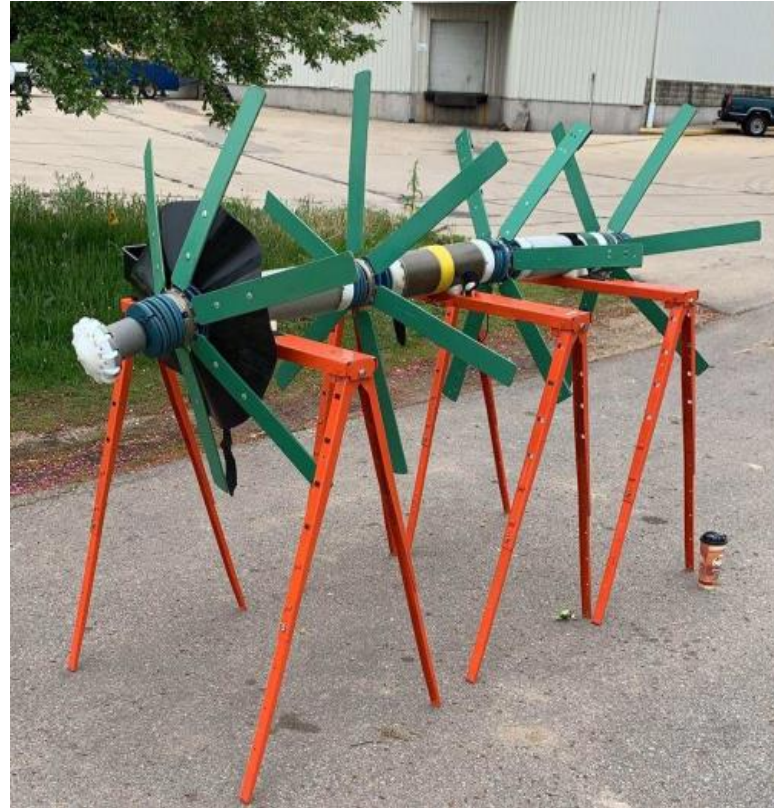
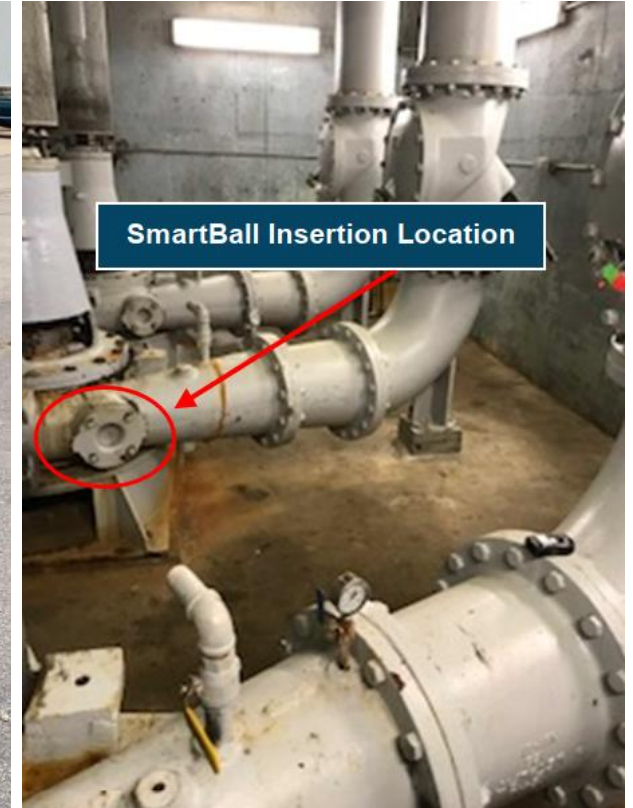
Dubuque, IA: High Consequences of Failure Warranted Additional Condition Assessment

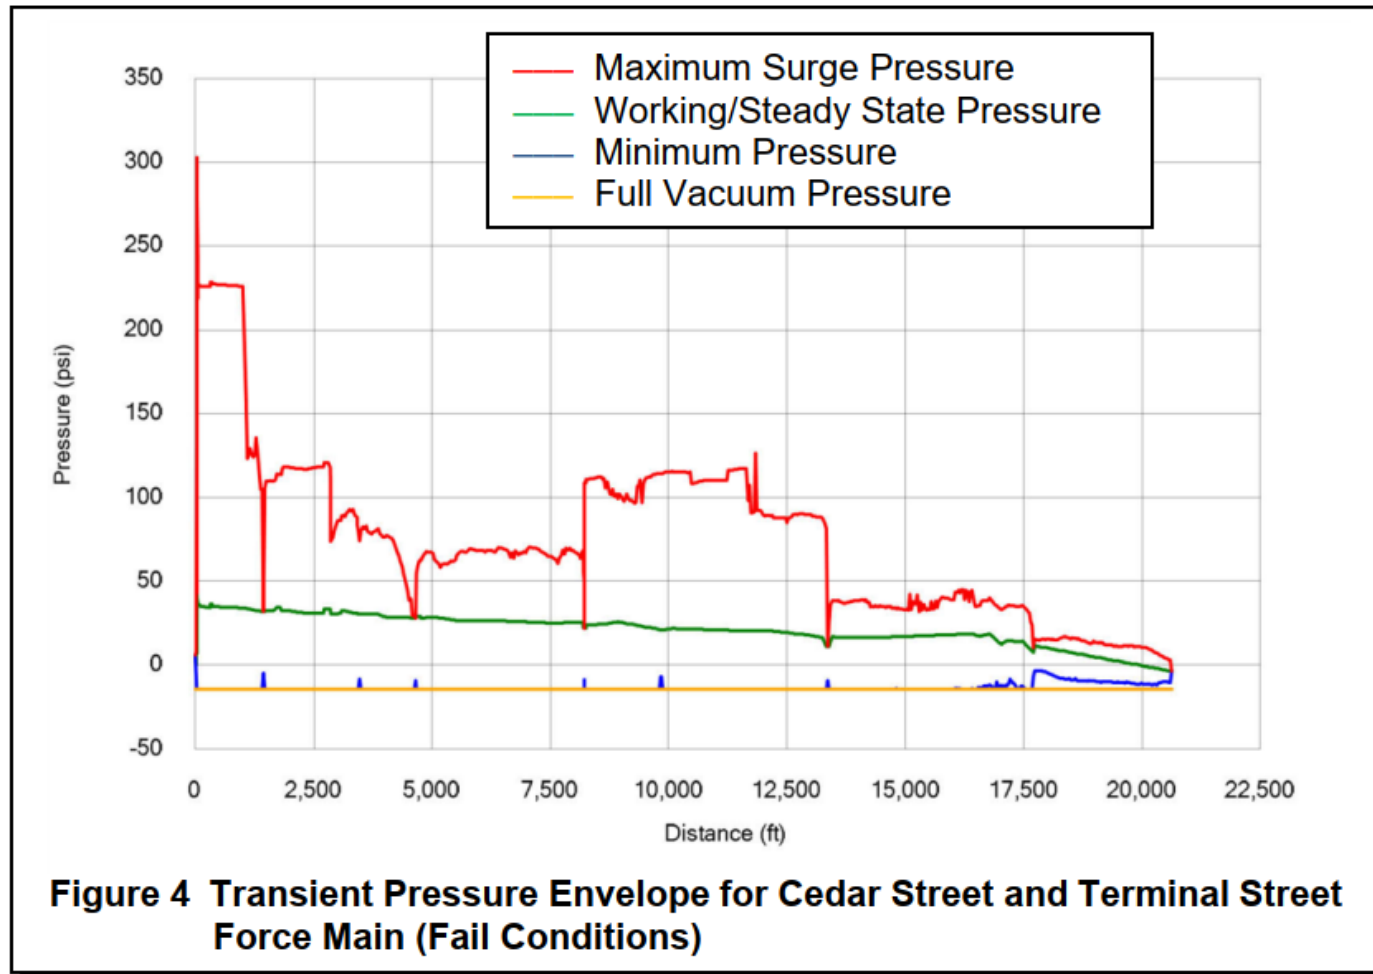
Dubuque, IA: Surge Analysis Identified Risks
