# Stevens Point Recycles, Reuses, and Reaps the Benefits of Abandoned Infrastructure

**Kim Halverson, City of Stevens Point  
Sandra Kimmler, Donohue & Associates, Inc.**

**CITY OF STEVENS POINT  
Water & Wastewater Department**

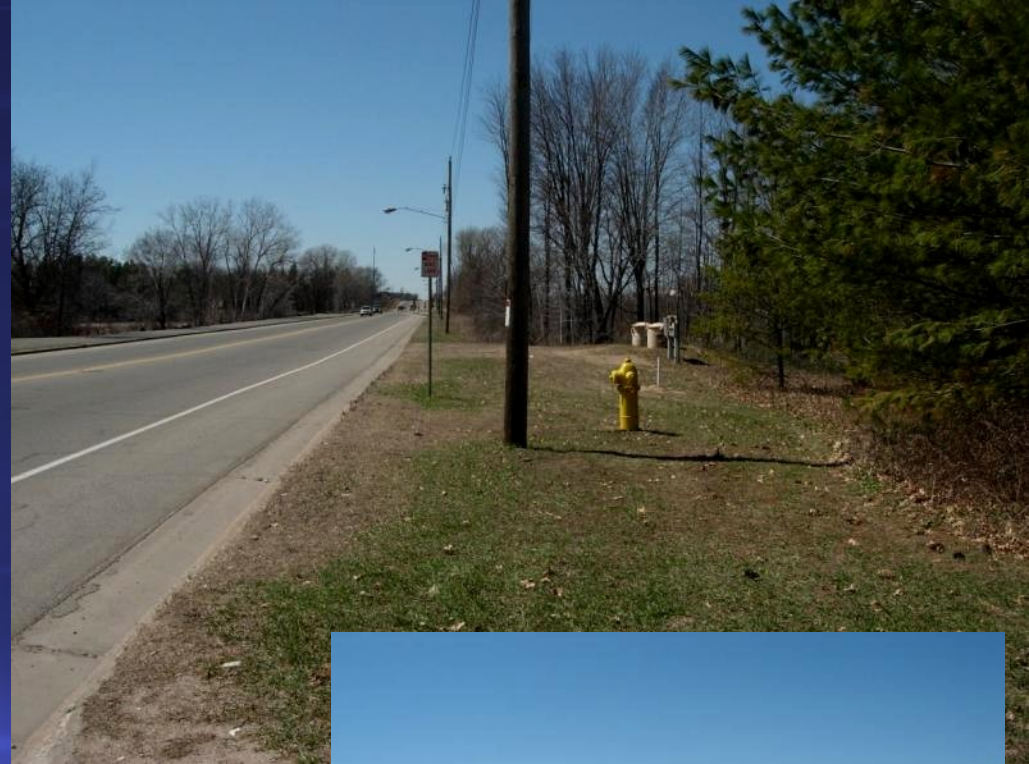
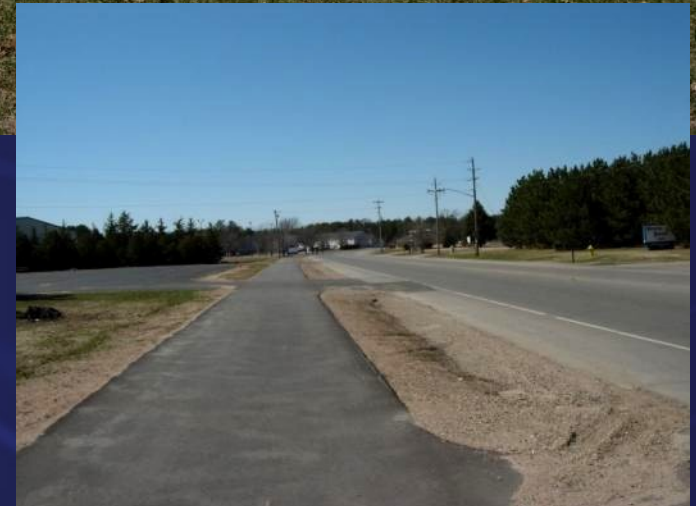
# Newly-Constructed Bike Path

- Constructed in 2007
  - Extends from the Plover River along Industrial Park Road
- The City did not want to disturb the new bike path

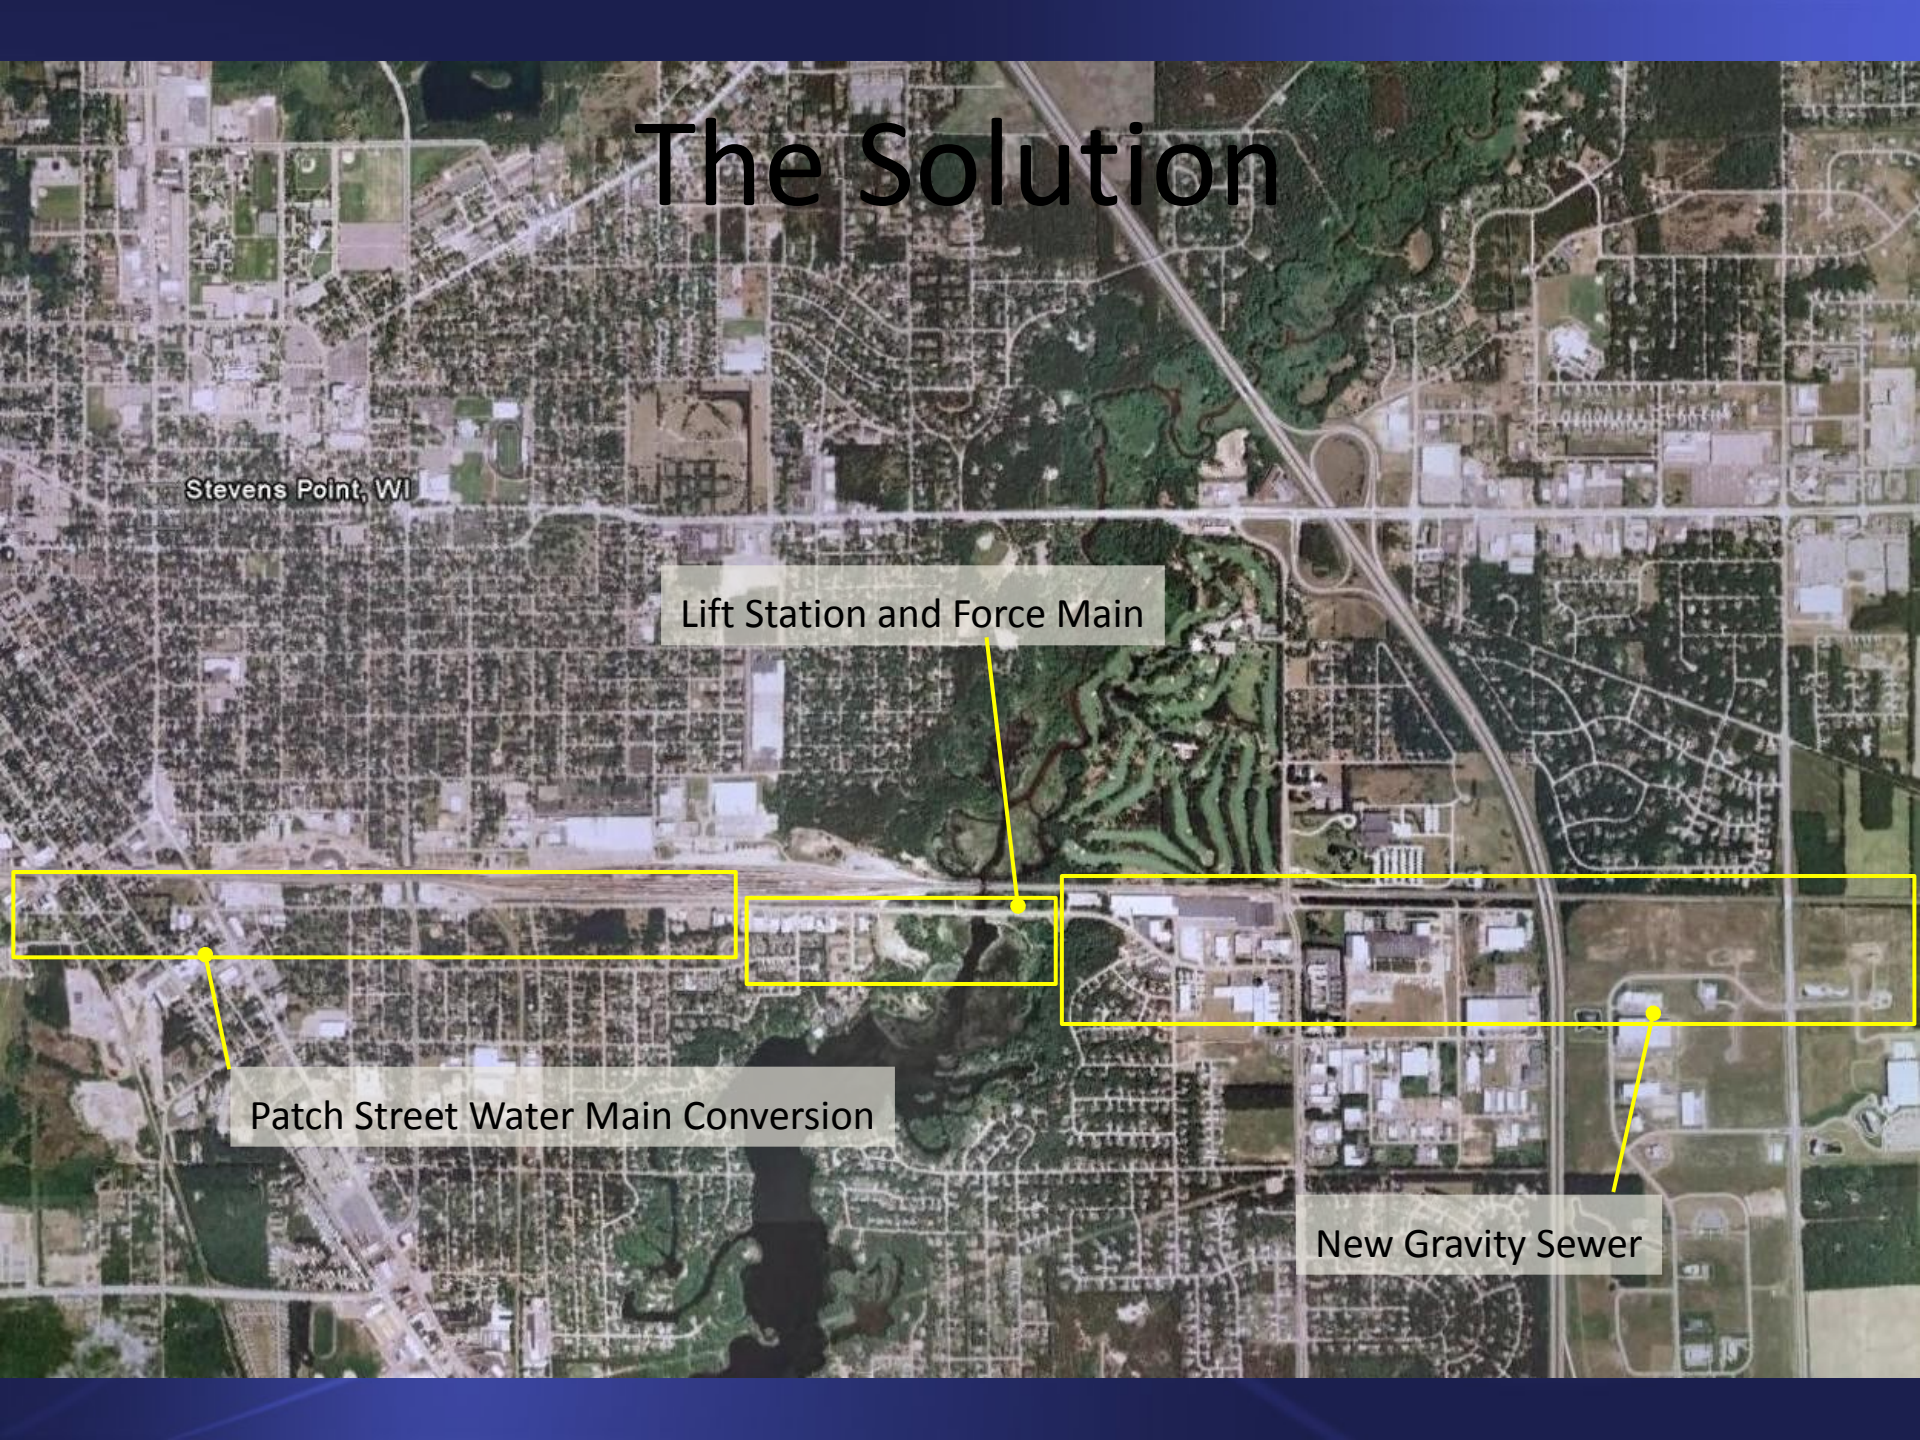
# The Solution

Stevens Point, WI

Lift Station and Force Main

Patch Street Water Main Conversion

New Gravity Sewer

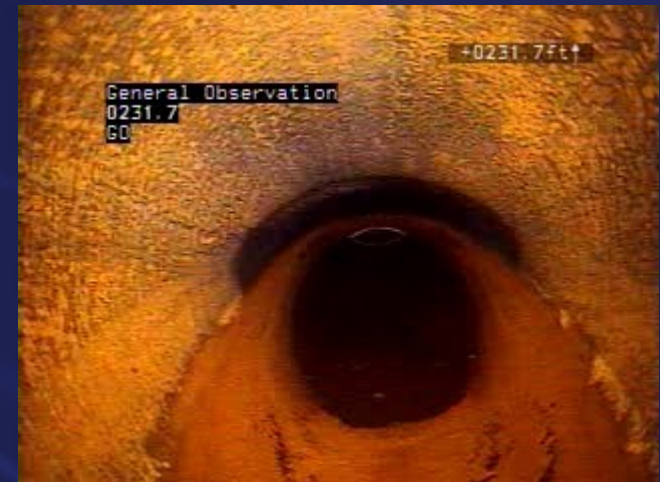
- Had to determine the condition, location, and elevation of existing water main
  - Televised water main. View bends, obstructions, or anything that would hinder lining.
  - Ground Penetrating Radar (GPR)

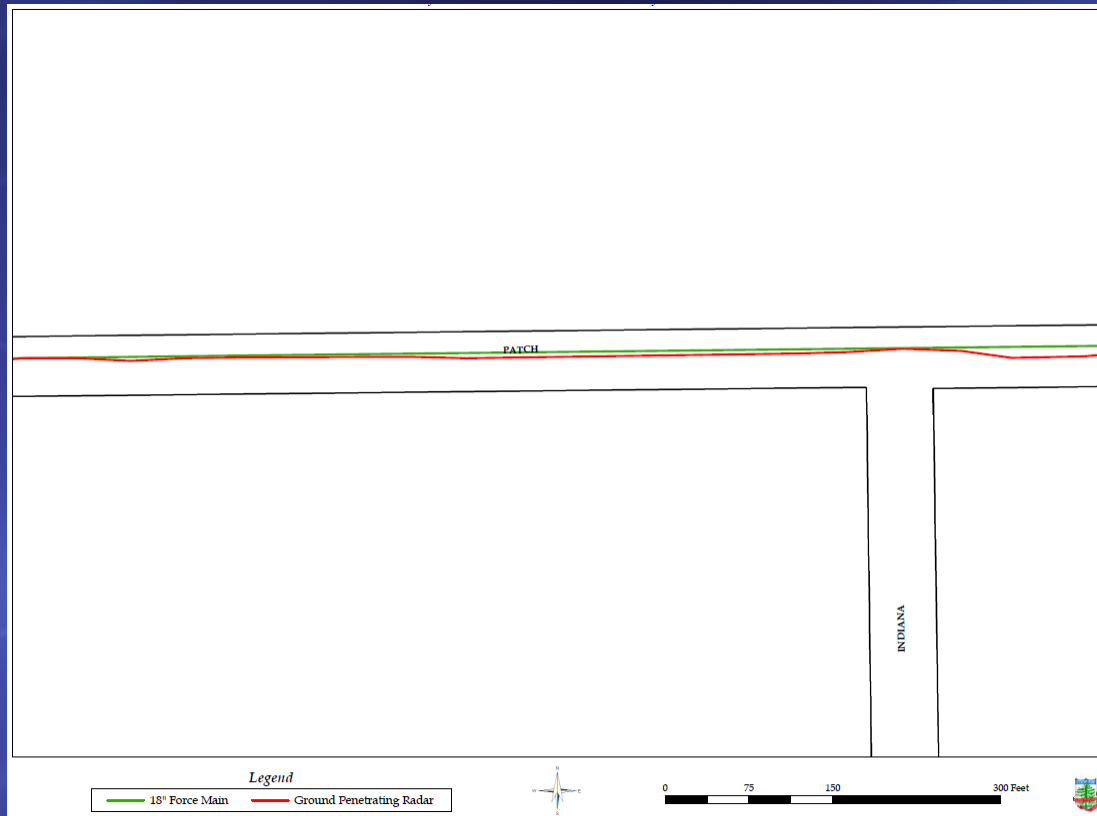
# Ground Penetrating Radar

*Railroad Yard*
