Comprehensive Manhole Assessment & Rehabilitation Program – Fond du Lac Case Study

Wisconsin Wastewater Operators' Association

Randy Langer, P.E.

Strand Associates, Inc.®

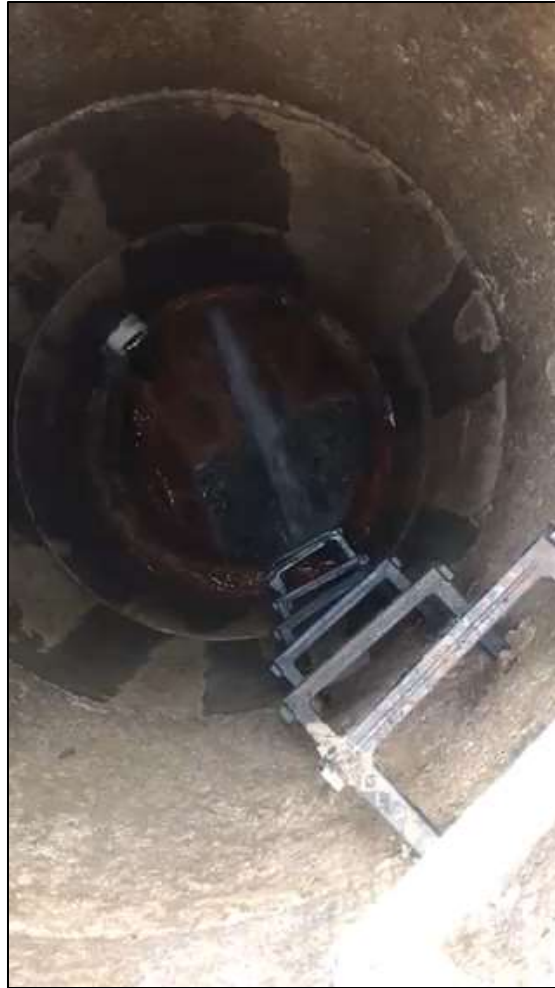
...But They Shouldn't Be!

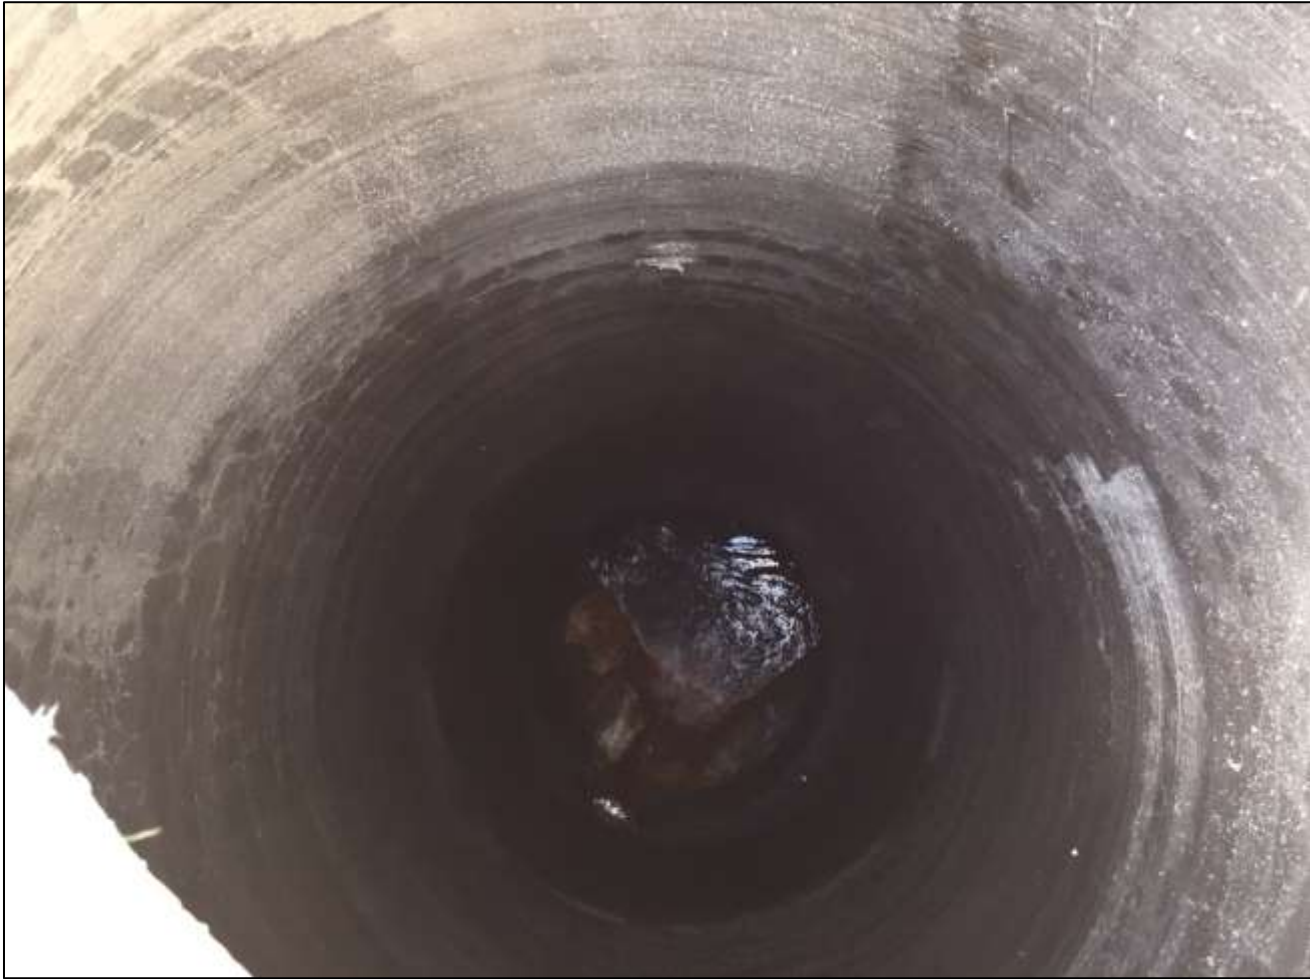
Same Manhole, After Rehabilitation

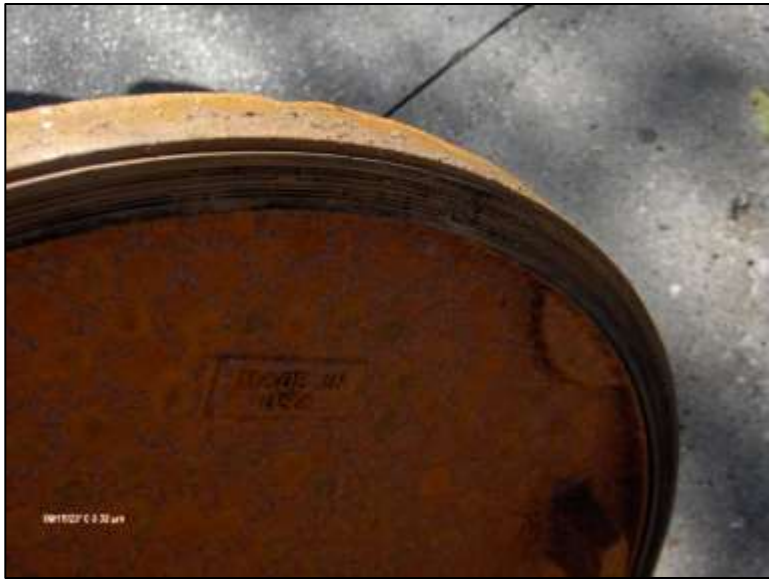
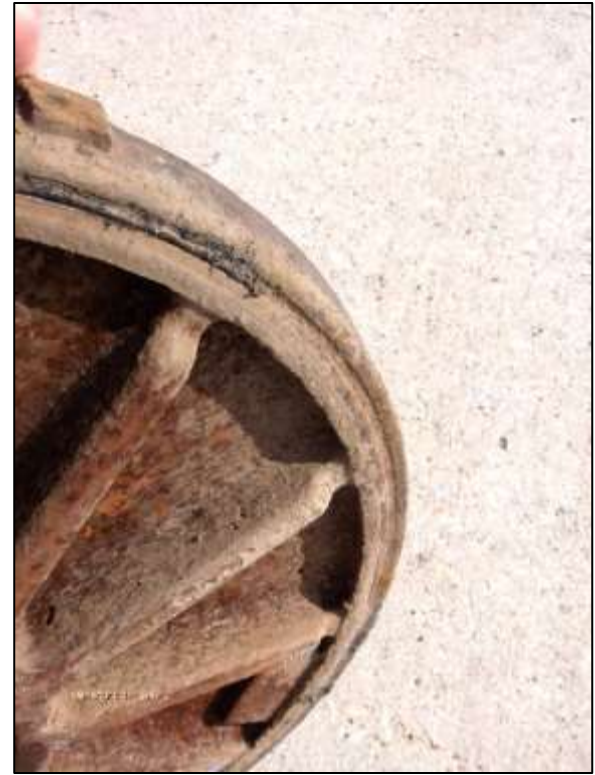
Cover and Gasket Replacement

- Differing types
- Cover cannot be too worn
- Prep important!
- Marginally successful

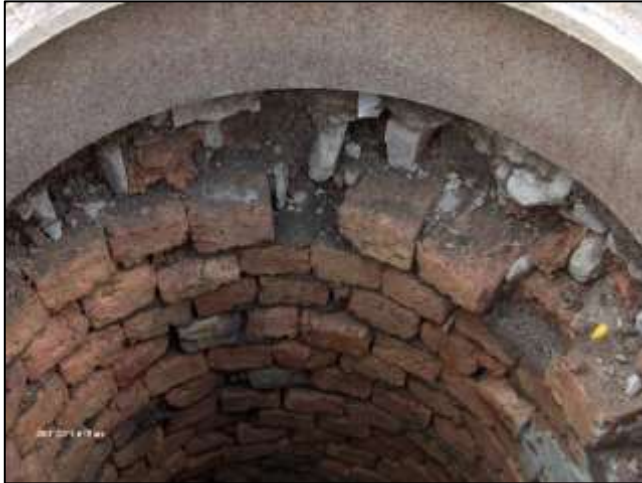
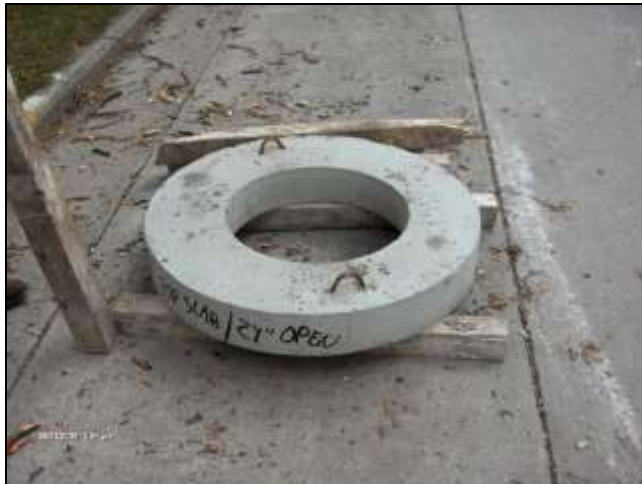
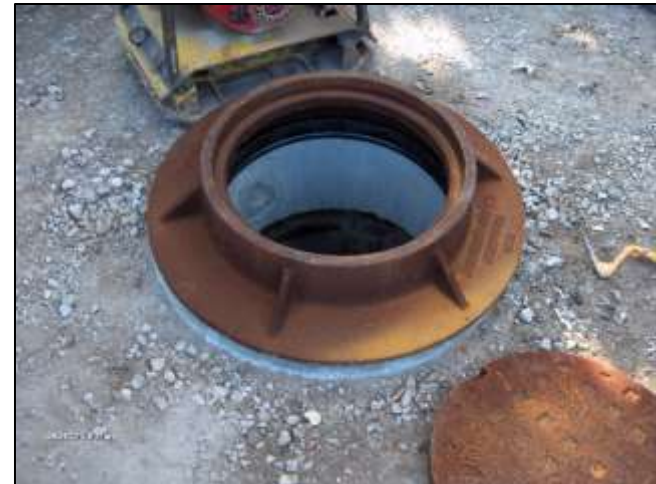
Top Replacement

- Brick vs precast cone?
- Compaction – consider flowable fill
- New chimney rings

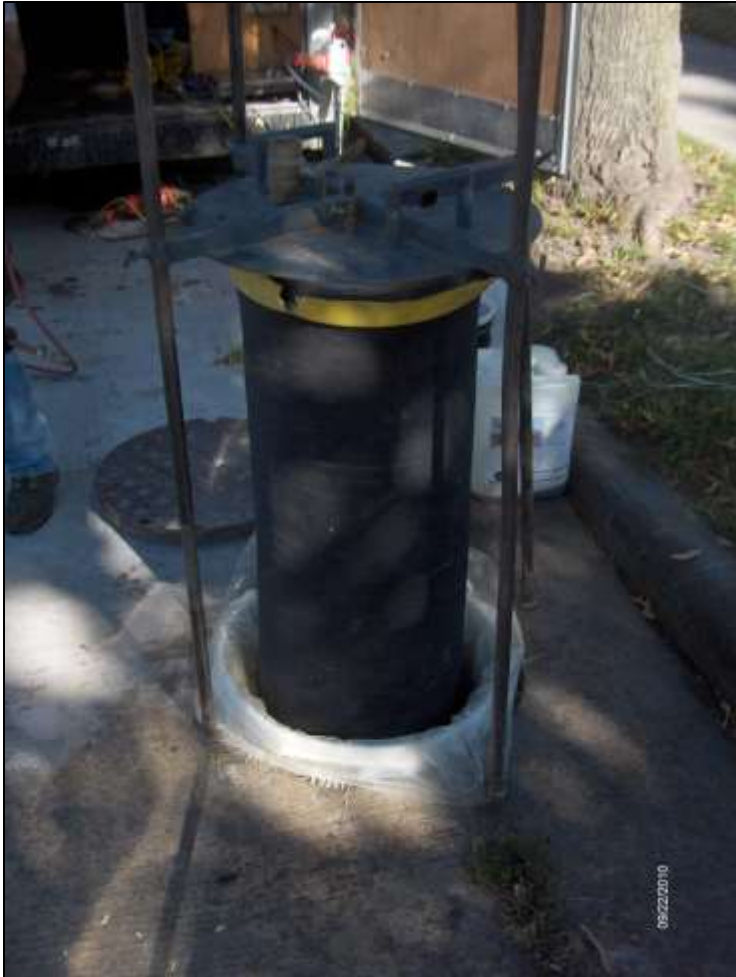
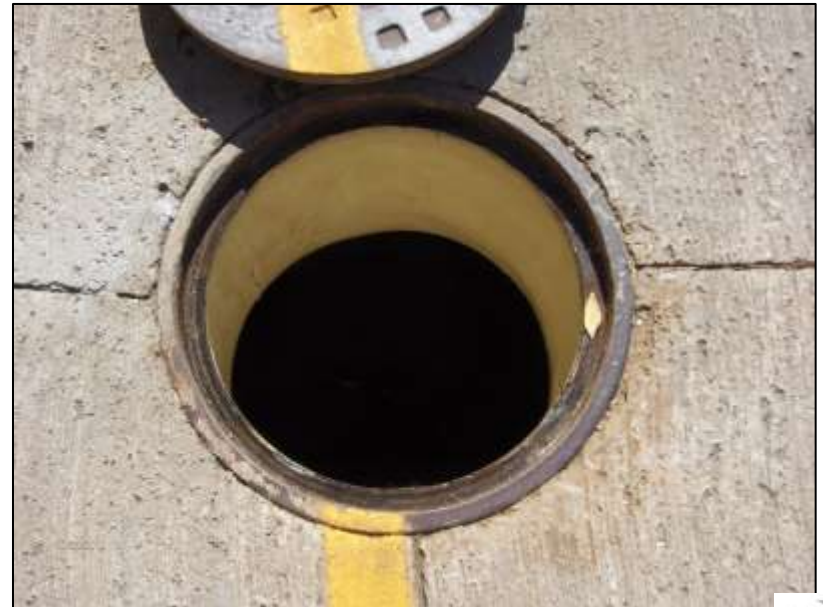
Cured-In-Place Chimney Liner

- Geometry of chimney

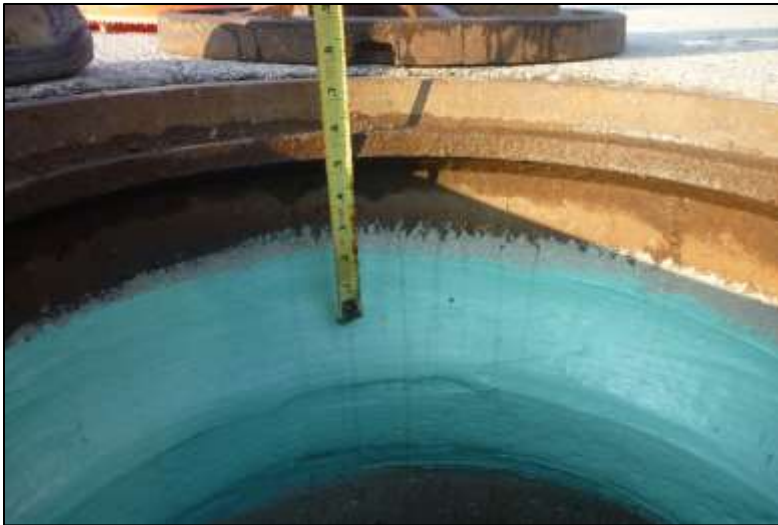
Hand Applied Chimney Liner

- Accommodates changes in chimney geometry
- Prep work, application methods
- Timing of application depends on manhole construction

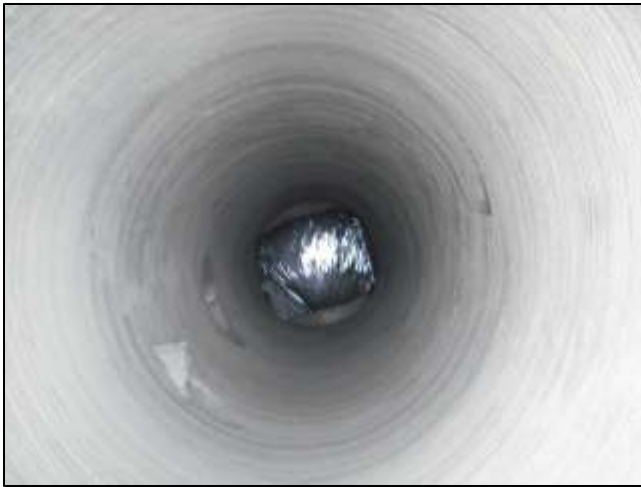
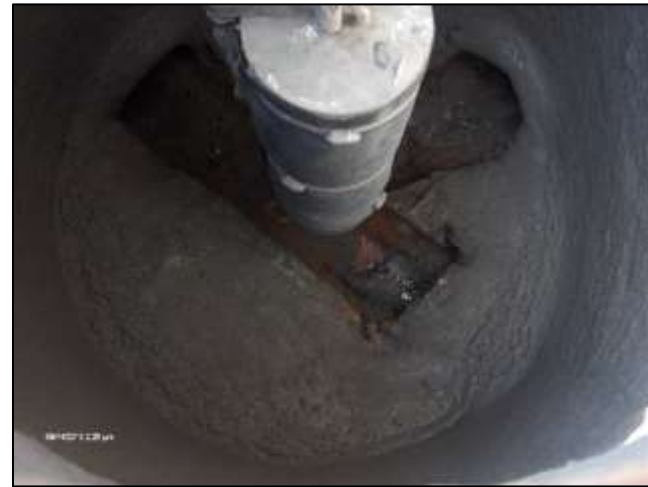
Cementitious Liners

- Differing materials
- Application methods

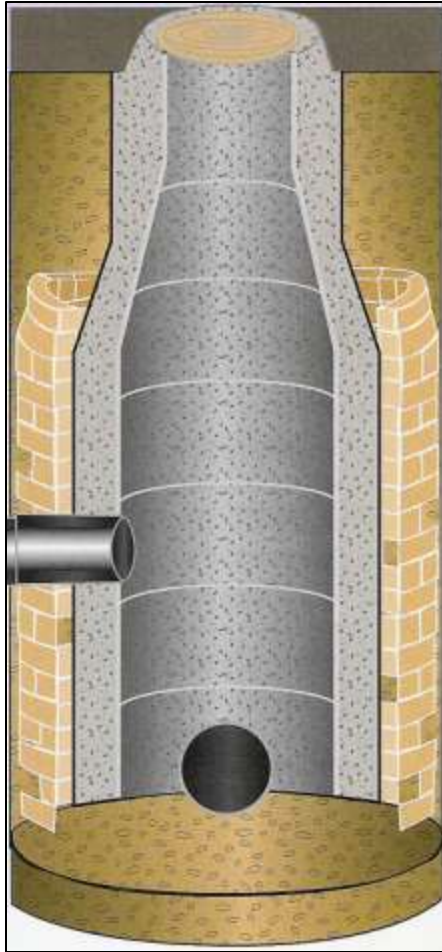
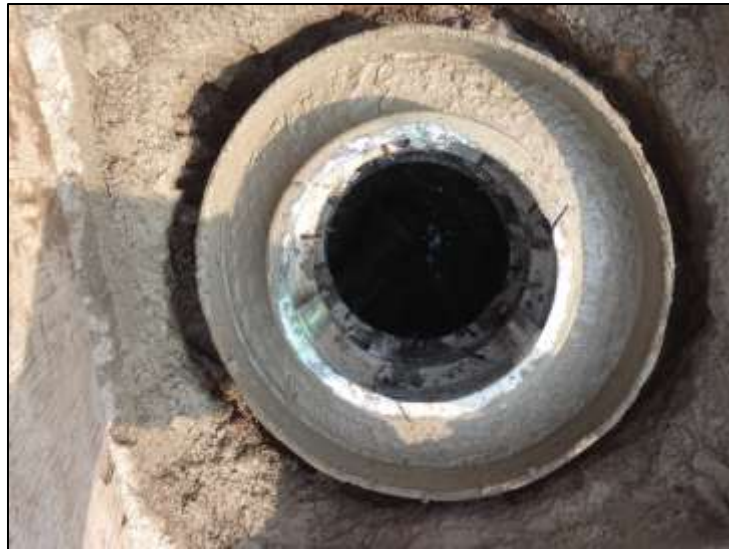
Cast-In-Place Manhole

- Existing manhole serves as exterior form
- Minor excavation required

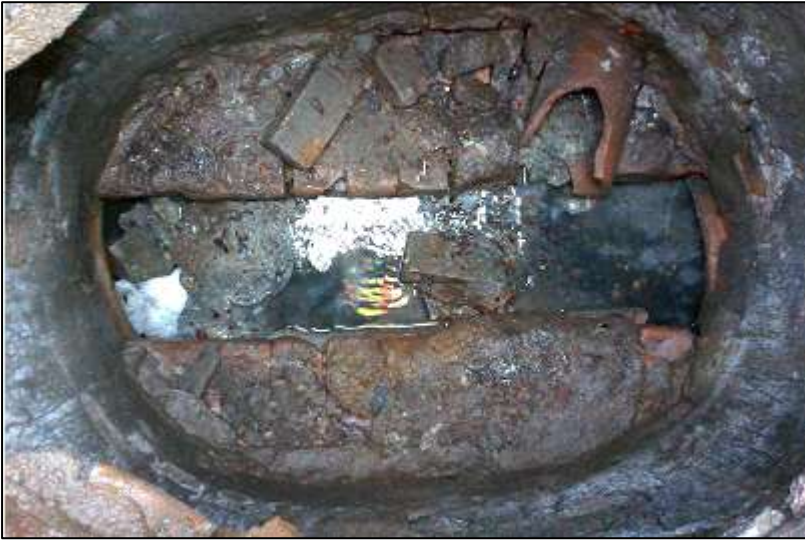
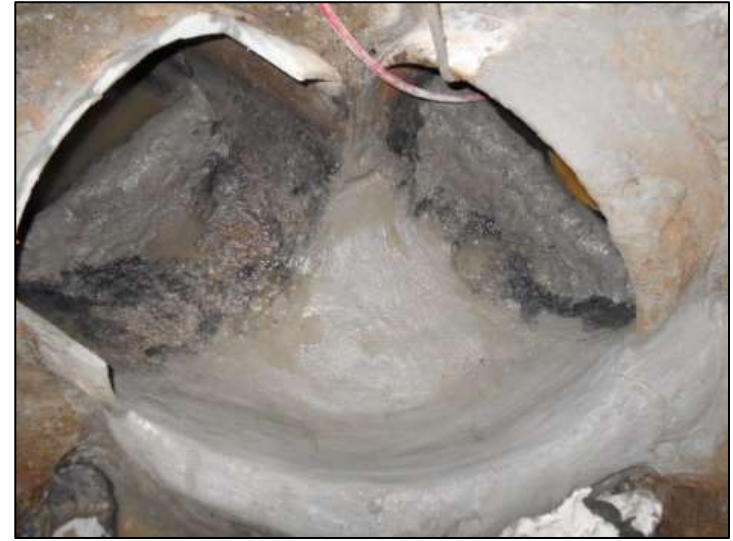
Bench/Channel Reconstruction

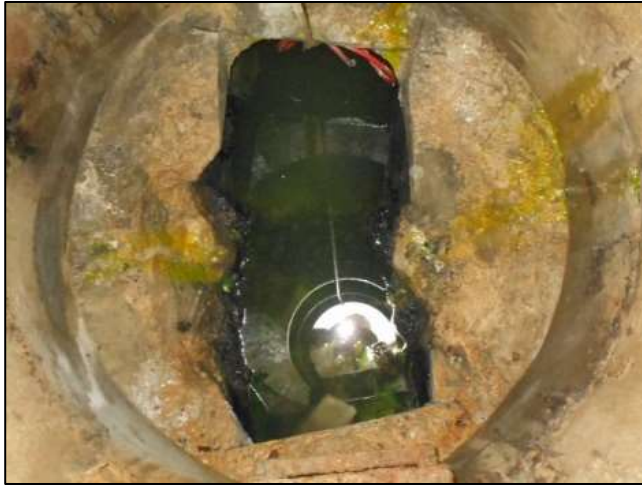
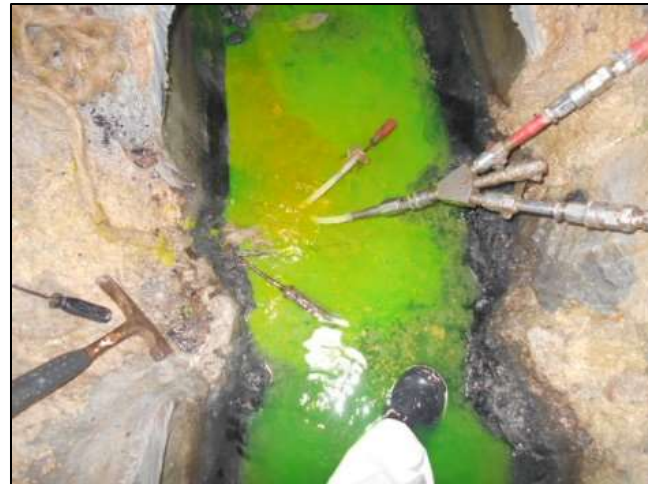
Chemical Grouting

- Differing grout materials
- Differing techniques

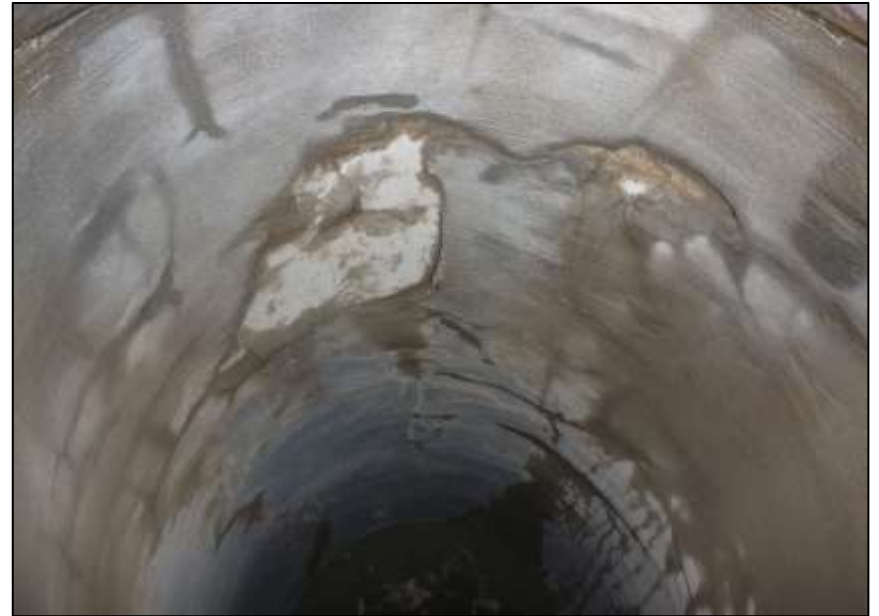
Construction Observation/Testing

- Verify prep work – Very important for coatings
- Thickness
- Continuity of coatings – holiday testing
- Compressive strength
- Adhesion testing
- Manufacturer's directions!

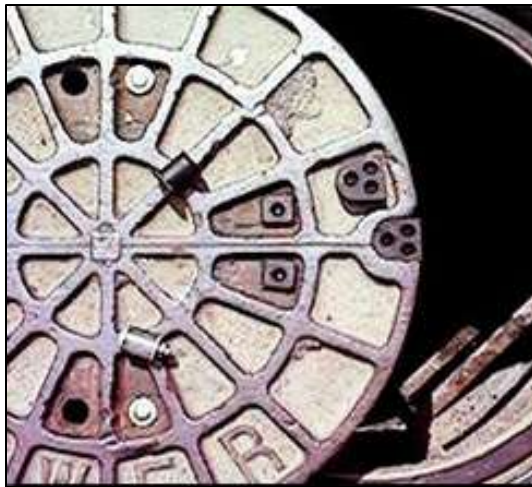
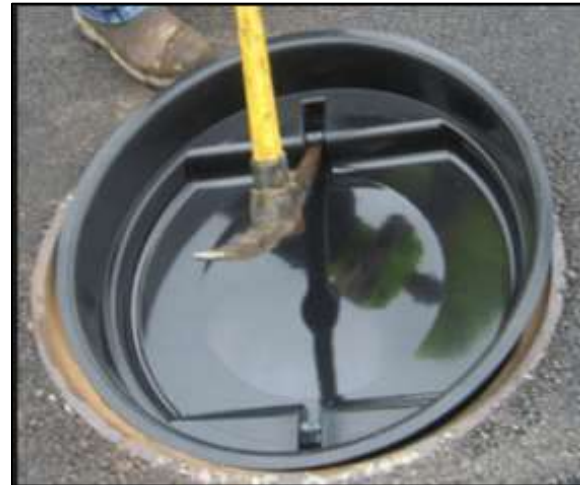
Other Cover Rehabilitation

- Plug pick holes
- Frame gasket
- Inflow dish
- Replace!

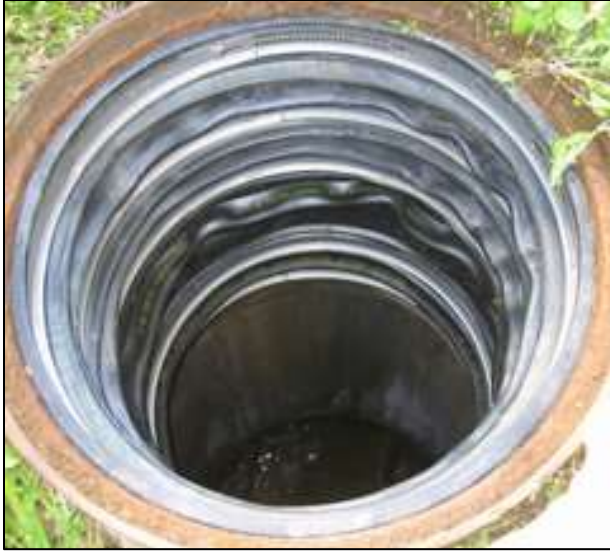
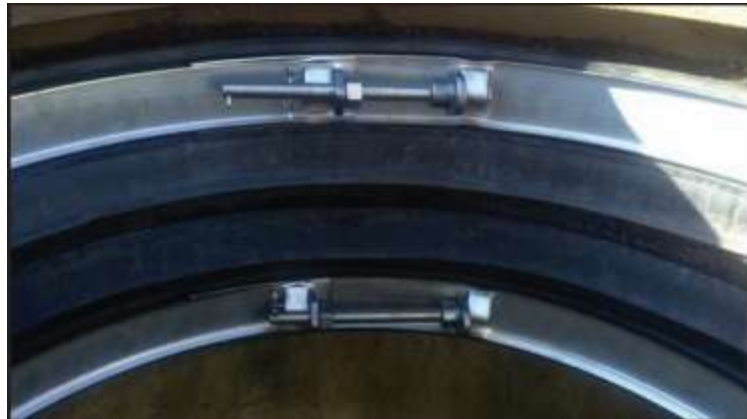
Internal Mechanical Chimney Seal

- Chimney geometry
- Easily verifiable during construction

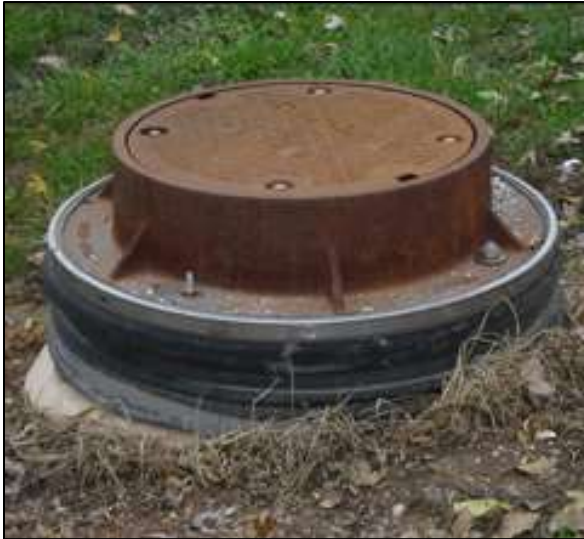
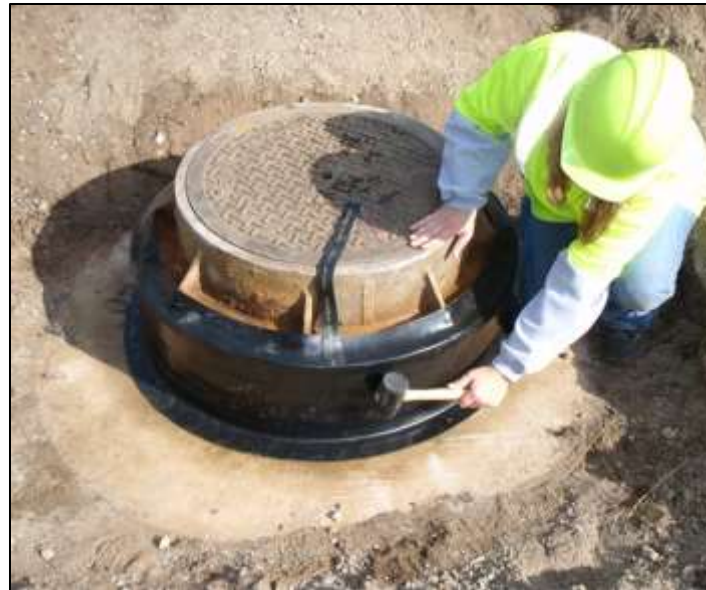
External Chimney Seal

- Chimney geometry
- Mechanical vs. heat shrink vs. adhesive

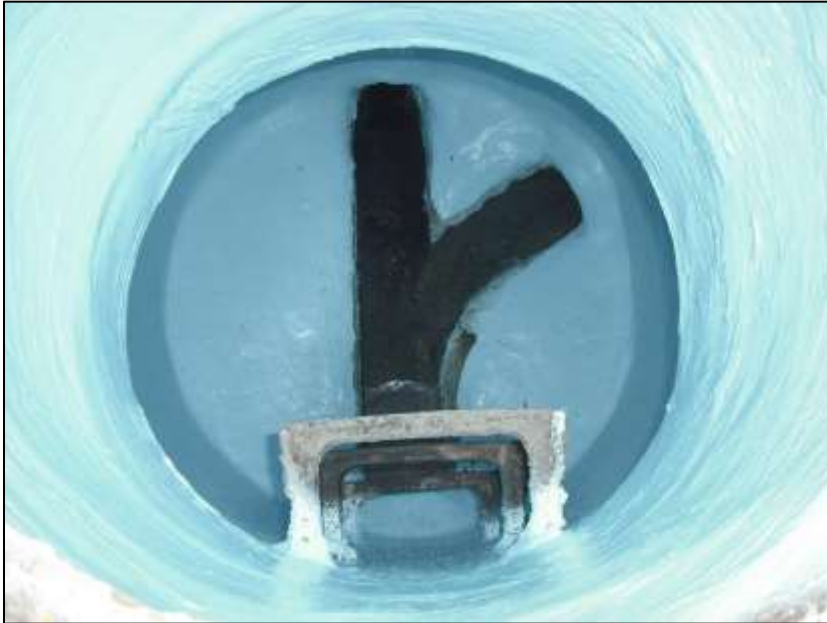
Epoxy Coatings

- Several different types
- Corrosion protection
- Prep work!!!

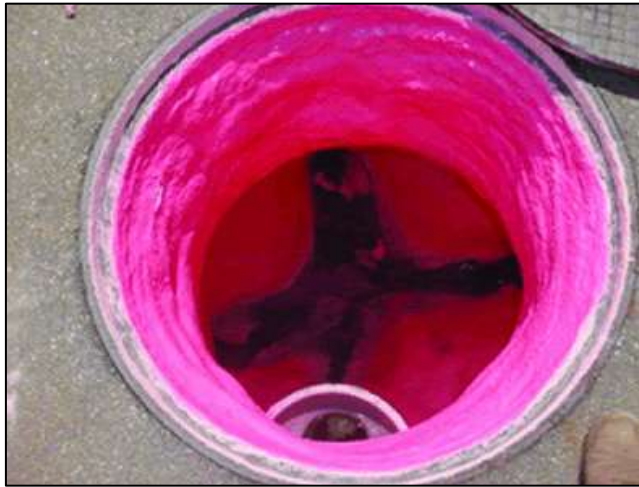
Modified Polymer Skin Panel

- Several different types
- Corrosion protection and I/I
- Prep work!!!

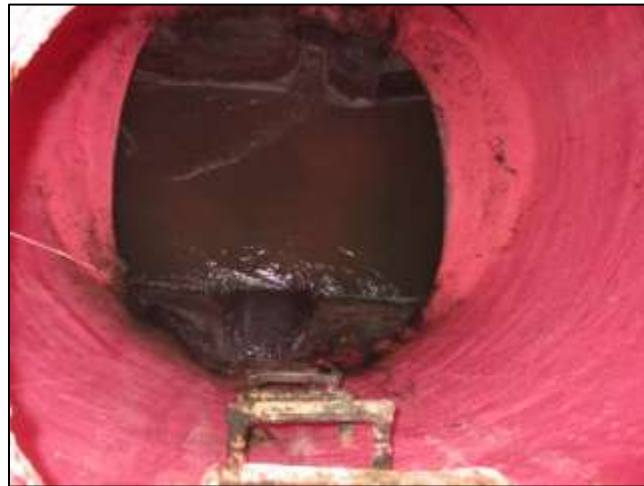
Structural Polyurethanes

- Several different types
- Corrosion protection, I/I, structural

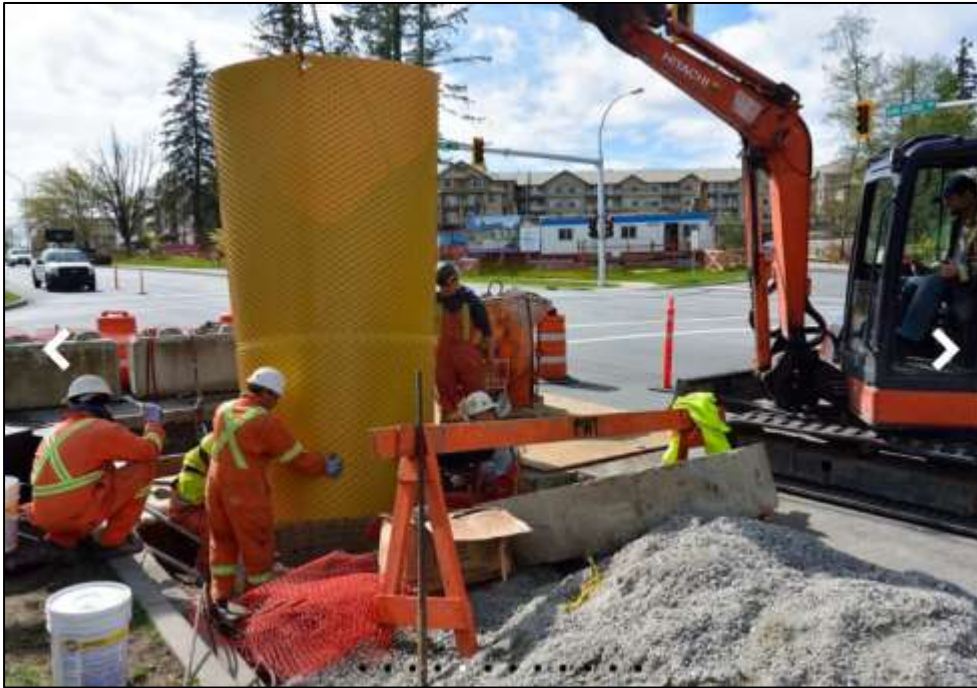
PVC and HDPE Liners

- Rehabilitation or new construction
- Custom fit

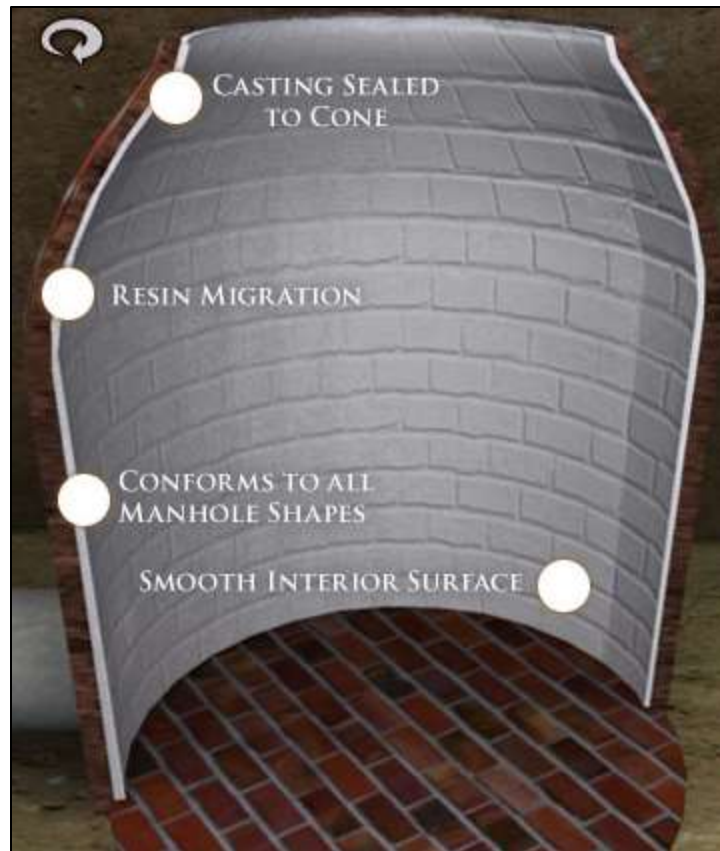
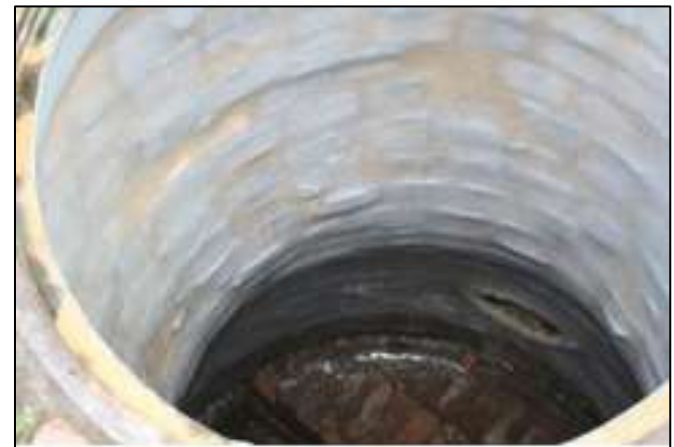
Full Depth CIP Lining

- Custom fit liner
- Corrosion protection
- Structural
